INS Ang	re – Walls and Bastions		001(1) and 238
		Common Ref No: 001(1) and 238	
		Card No: 1	
THE REAL PROPERTY.		Ward (Part): A (Part II)	
		CS No: 226 (Colaba division)	
		Plot Area: - Part of 50387.52 sq. m	
1/2		· · · · · · · · · · · · · · · · · · ·	
11		B U Area: -	TOWN HALL
	<b>对于</b>	Date: 19/04/05	
	11/1/	Recorded by: Prachi Merchant	
	THE PARTY OF THE PARTY OF	Reviewed by:	
		Int: Refer#	HARBOUR
		Ext: Refer #	
	to diversi	Photo Ref: 001&238,239,240_Bombay castle	
			Location Plan

1.0		Denomination	
1.1	Name of Premises	INS Angre – Walls and Bastions.	
1.2	Earlier Name	Bombay Castle.	
1.3	Built in:	1665	Extension Date: -
2.0		Access

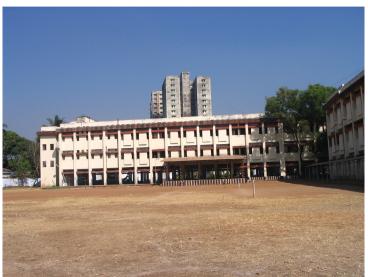
Newly constructed building of Kendriya Vidhyalaya School with no trace of the Cemetery
