TABLE OF CONTENTS		
		LIST 'A'		
Sr. No	Ward	Listed Properties	Page No	Grade
1	L	225-L-Reporter House	001-004	III
2	L	301-L- Swadeshi Mills	005-009	IIB
3	L	415-L-Well	010-012	III
4	L	614-L-Tank at Kale Road	012-016	IIB
5	L	706-L-Holy Cross Church	017-020	IIB
6	L	709-L-Paul-Periera House	021-023	III
7	L	727-L-Sarveshwar Mahadev Temple	024-027	III
8	L	878-L-Pereira House	028-030	III
9	L	909-L-Foot Over-Bridge	031-033	III
10	M	202-M-Diwan Bawdi	034-036	III
11	M	208-M-Dieal	037-040	III
12	M	209-M-Joseph Haven	041-044	III
13	M	212-M-Dream Land	045-047	III
14	M	215-M-Pam Cote	048-050	III
15	M	217-M-Mathildes	051-055	III
16	M	224-M-Ganesh Talao	056-058	IIB
17	M	604-M-Allbless Leper Home	059-062	III
18	M	607-M-Mahul Jetty	063-065	III
19	M	609-M-Ashish Tank	066-068	IIB
20	M	642-M-Pioneer House	069-071	III
21	M	643-M-Marian Mansion	072-074	III
22	M	644-M-Belvedere House	075-077	III
23	M	863-M-Teresa Cottage	078-080	III
24	M	864-M-The Grotto	081-083	III

225-L		REPORTER HOUSE

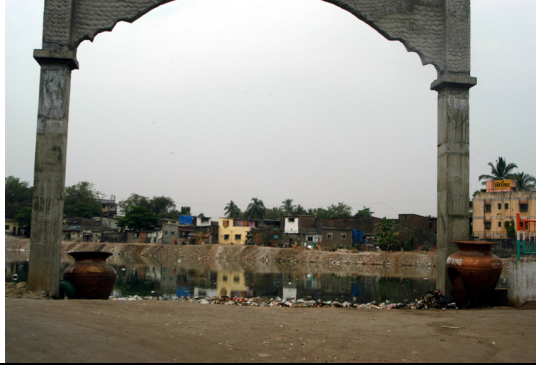
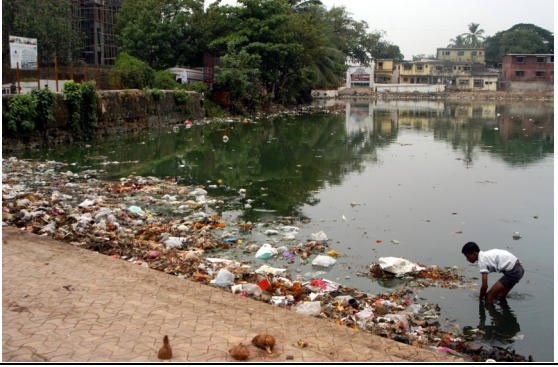
PHOTOS SERIES 614-L

Entrance arch for the Tank		Garbage along the newly constructed ghats

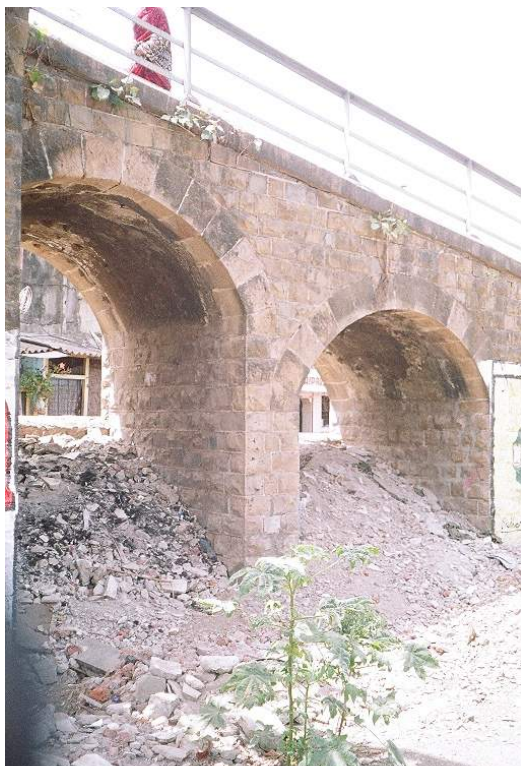
9.6	Roofing	Poor
9.7	Articulation & Finishes	Poor
9.8	Services	Poor
9.9	Out buildings	Poor
9.10	Over all condition	Poor
10.0	Transformation	
10.1	Form	None
10.2	Structure	Weathering and damage

10.3	Articulation & Finishes	Weathering and damage, vegetation growth
11.0	DP Remarks / Perceived Threats	
		Destruction due to neglect, demolition, Modernisation

Ramp supported by arches

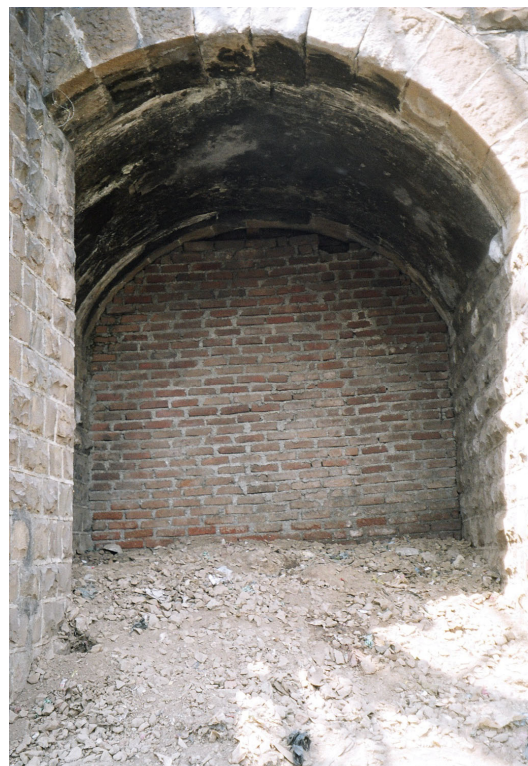
Road side of the arch closed in brick

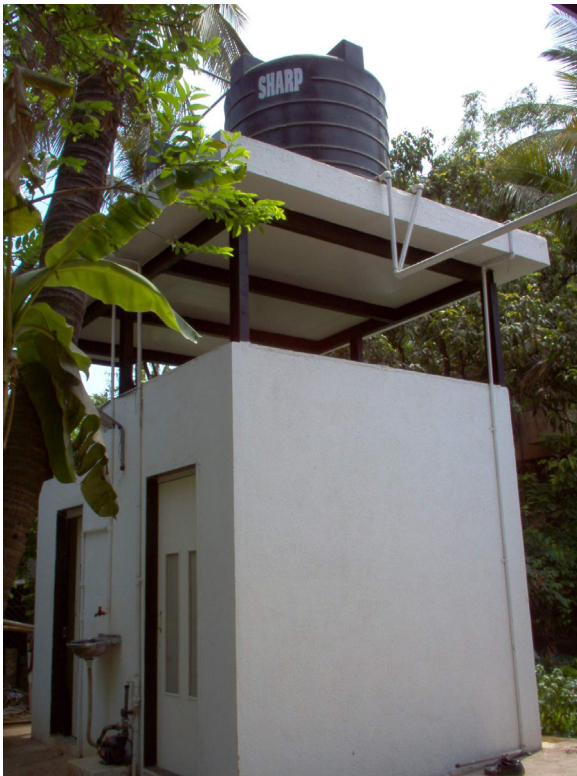
Existing toilet block outside the bungalow retained and addition of water tank above it

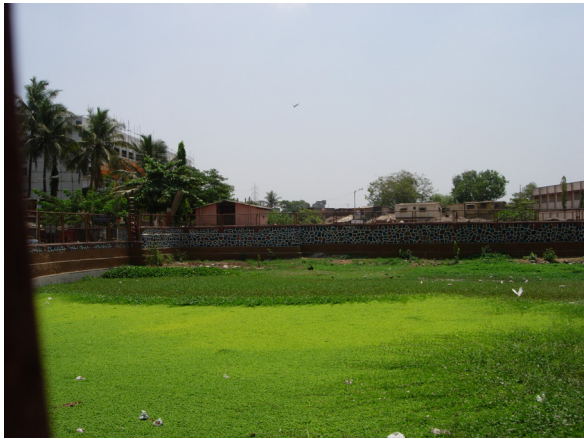
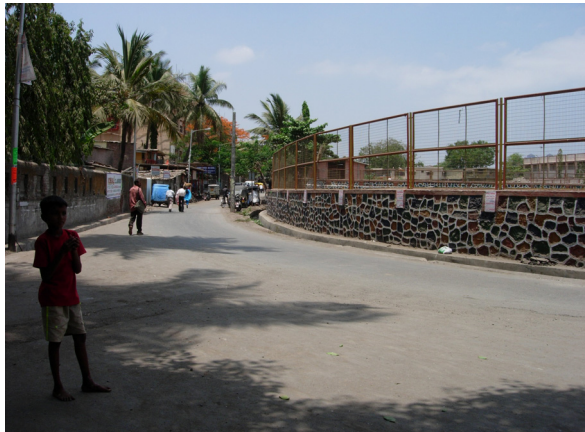
PHOTO SERIES 224-M

Water is fully covered with weeds after monsoon	The compound wall / fence along the access road

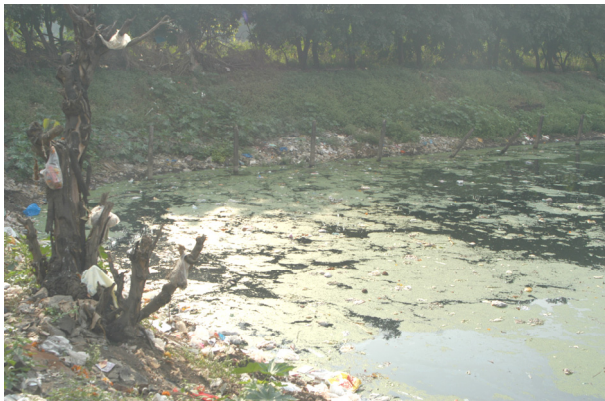
PHOTO SERIES 609-M-ASHISH

Tank is full of weeds	The banks have a few good trees

Water body full of algae and garbage on the banks	Compound wall / fencing around the tank

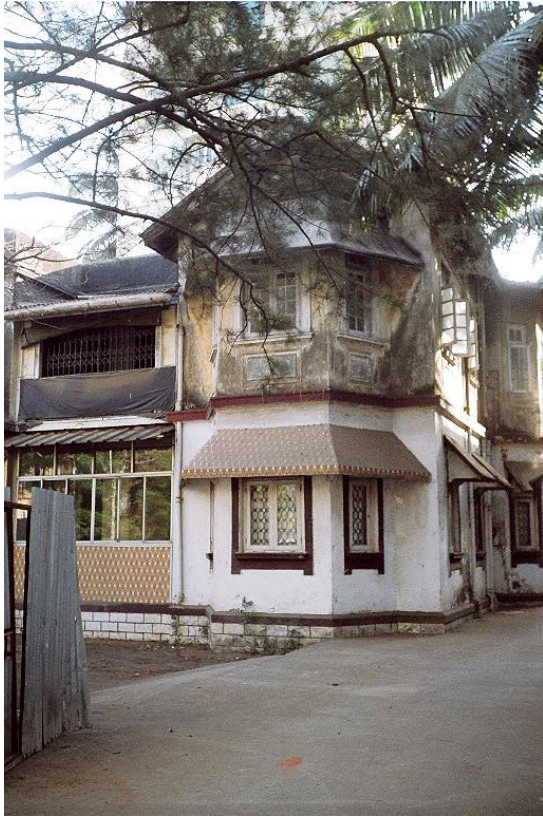
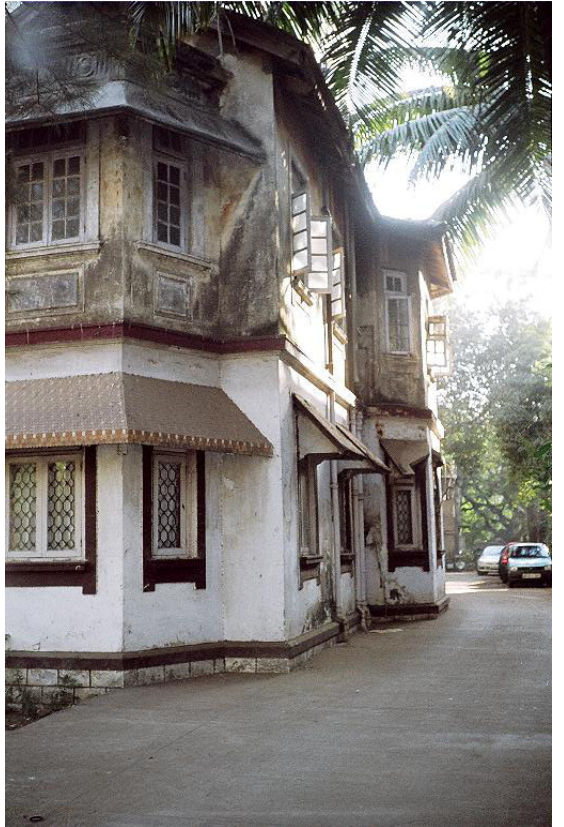
PHOTO SERIES 643-M-MARIAN MANSION

<p>Entrance view of the mansion</p>	<p>The original bay window (seen on the first floor). The modified window is seen on the ground floor.</p>

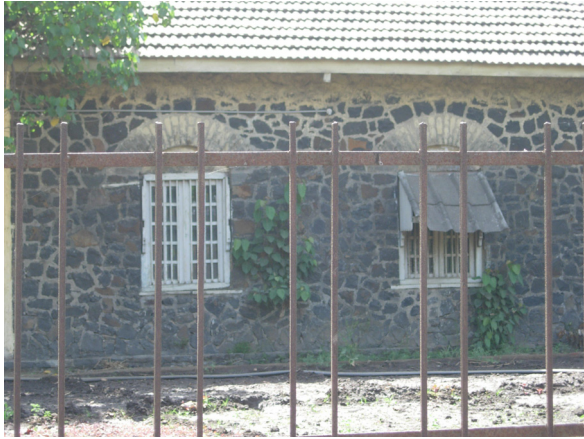
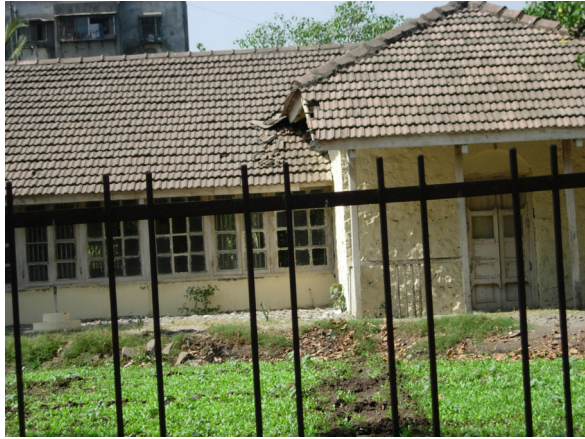
<p>PHOTO SERIES 316-S-SALT COMMISSIONERS OFFICES</p>

12.0		Additional Notes / References / Documents Available
		The Salt Commissioner's office has a well developed infrastructure related to salt making industry. It includes offices, staff quarters and schools. Over the years this infrastructure is deteriorating due to non maintenance

<p>Segmental Arched windows with wooden shutters</p>	<p>Independent campus almost bearing an abandoned look</p>

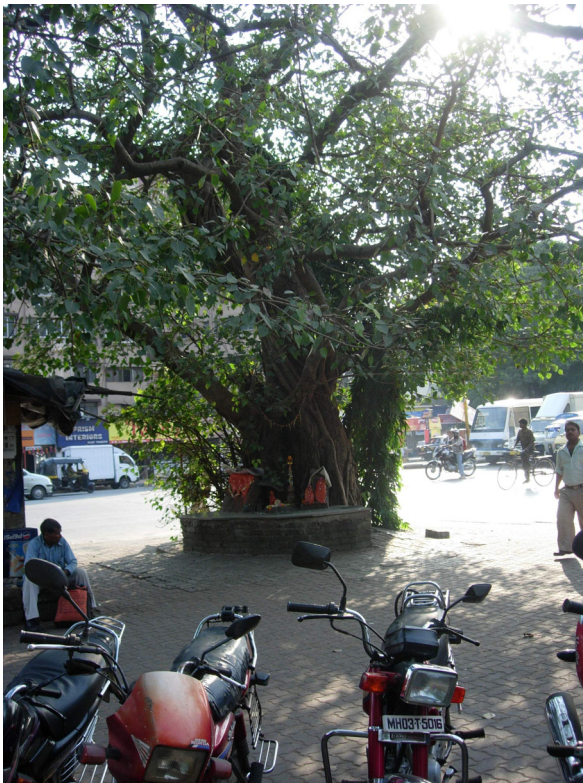
Informal parking lots along traffic islands
