Card No.: A-1

Ward (Part): A-IV

Date: August, 2005

1.0	Denomination					
1.1	Name of Premises	Ashley House / Sommerset House				
1.2	Earlier Name	Not applicable				
1.3	Built in	Mid 20 th century	Extension Date (i	f any)	Not applicable

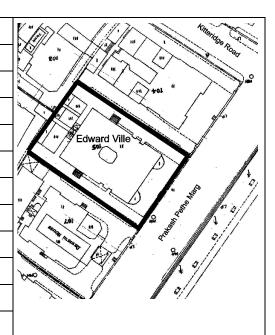
Ref.: Ville

9.0	Condition					
9.1	Plinth	Fair (To be check for settlements)				
9.2	Walls	Fair (No dampness or cracks observed)				
9.3	Floor	Fair (No sagging observed)

9.4	Stairs	Fair (Wooden members need maintenance)				
9.5	Openings	Fair				
9.6	Roofing	Fair (Leakages observed at few places)				
9.7	Articulation & Finishes	Fair

9.8	Services	Fair (Drainage pipes need maintenance)				
9.9	Outbuildings	Fair				
9.10	Overall condition	Fair Maintenance level Fair				
10.0	Transformation

10.1	Form	Hoardings and chajjas added later.				
10.2	Structure	Wooden chajjas replaced with aluminum chajjas.				
10.3	Articulation & Finishes	No transformation

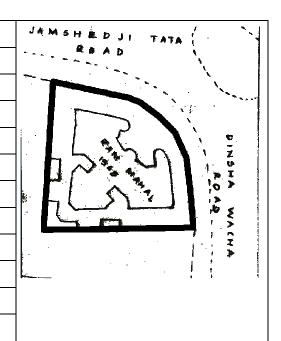
Ref.: Mahal

9.0	Condition			
9.1	Plinth	Good (No settlement or cracks observed)		
9.2	Walls	Good (No dampness or cracks observed)		
9.3	Floor	Good		
9.4	Stairs	Good (Wooden members in good condition)

9.5	Openings	Good		
9.6	Roofing	Good (No leakage observed)		
9.7	Articulation & Finishes	Good		
9.8	Services	Good (Drainage pipes need no replacement)		
9.9	Outbuildings	Good

9.10	Overall condition	Good Maintenance level Good		
10.0	Transformation			
10.1	Form	Sliding windows and grills added later.		
10.2	Structure	No transformation

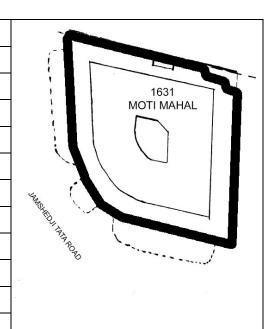
Ref.: Mahal

9.0	Condition				
9.1	Plinth	Fair (No settlement or	cracks observed but n	eeds maintenance)	
9.2	Walls	Fair			
9.3	Floor	Fair			
9.4	Stairs	Fair (Needs maintena	nce)

9.5	Openings	Fair			
9.6	Roofing	Fair (No leakage obse	rved)		
9.7	Articulation & Finishes	Fair			
9.8	Services	Fair (Drainage pipes n	eed maintenance)		
9.9	Outbuildings	Fair

9.10	Overall condition	Fair	Maintenance level	Fair	
10.0	Transformation				
10.1	Form	No transformation			
10.2	Structure	Top two floors added I	ater.		
10.3	Articulation & Finishes	No transformation

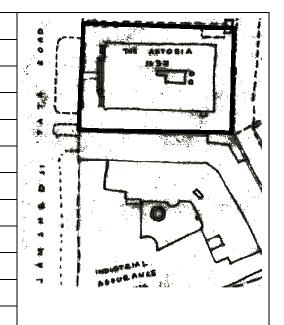
Ref.: Hotel

9.0	Condition	
9.1	Plinth	Good (No settlement or cracks observed)
9.2	Walls	Good (No dampness or cracks observed)
9.3	Floor	Good
9.4	Stairs	Good
9.5	Openings	Good

9.6	Roofing	Good (No leakage observed)
9.7	Articulation & Finishes	Good
9.8	Services	Good (Drainage pipes need no replacement)
9.9	Outbuildings	Good
9.10	Overall condition	Good Maintenance level Good

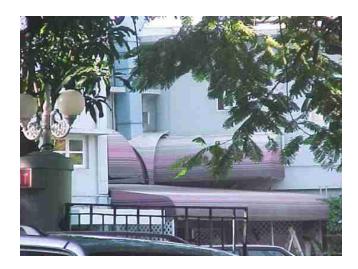
View obstructed by vegetation

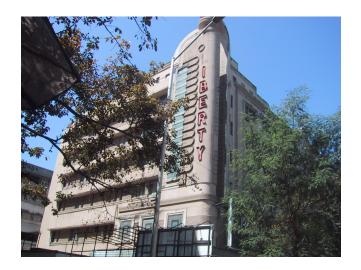
Typical Art Deco corner detail of the building

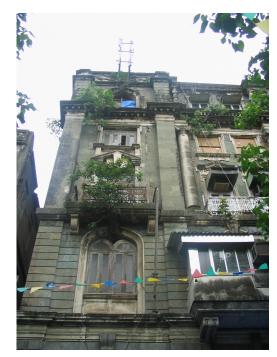
Front elevation blocked by the vegetation
