TABLE OF CONTENTS		
		LIST 'A'		
Sr. No	Ward	Listed Properties	Page No	Grade
1	L	225-L-Reporter House	001-004	III
2	L	301-L- Swadeshi Mills	005-009	IIB
3	L	415-L-Well	010-012	III
4	L	614-L-Tank at Kale Road	012-016	IIB
5	L	706-L-Holy Cross Church	017-020	IIB
6	L	709-L-Paul-Periera House	021-023	III
7	L	727-L-Sarveshwar Mahadev Temple	024-027	III
8	L	878-L-Pereira House	028-030	III
9	L	909-L-Foot Over-Bridge	031-033	III
10	M	202-M-Diwan Bawdi	034-036	III
11	M	208-M-Dieal	037-040	III
12	M	209-M-Joseph Haven	041-044	III
13	M	212-M-Dream Land	045-047	III
14	M	215-M-Pam Cote	048-050	III
15	M	217-M-Mathildes	051-055	III
16	M	224-M-Ganesh Talao	056-058	IIB
17	M	604-M-Allbless Leper Home	059-062	III
18	M	607-M-Mahul Jetty	063-065	III
19	M	609-M-Ashish Tank	066-068	IIB
20	M	642-M-Pioneer House	069-071	III
21	M	643-M-Marian Mansion	072-074	III
22	M	644-M-Belvedere House	075-077	III
23	M	863-M-Teresa Cottage	078-080	III
24	M	864-M-The Grotto	081-083	III

225-L		REPORTER HOUSE

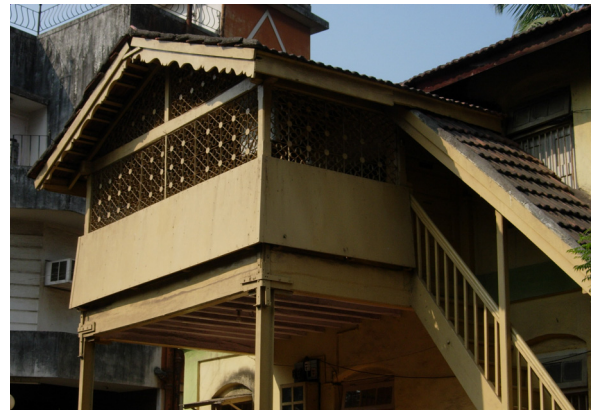
9.8	Services	Fair
9.9	Out buildings	N.A.
9.10	Over all condition	Good
10.0	Transformation	
10.1	Form	The wooden balcony is fully enclosed with MS sheets and grill. Most of the windows are internally fitted with Al sliding windows.

Enclosed Balcony with external staircase

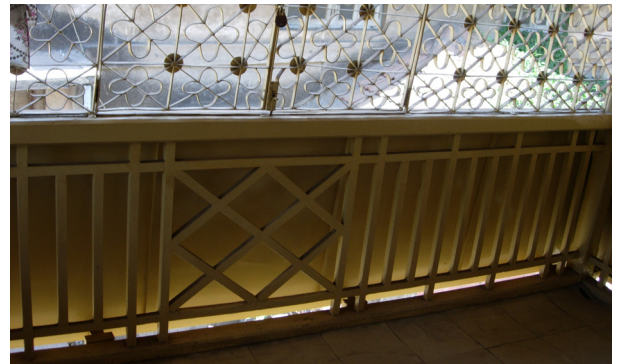
10.2	Structure	The balcony was initially supported on wooden posts which are now replaced by MS stanchions.
10.3	Articulation & Finishes	The decorative eaves boards of the main building are replaced with plain boards. The flooring on the ground floor is replaced with marble mosaic and tiles. The built-in seating of the entrance verandah is clad with glazed tiles and IPS flooring is replaced by vitreous tiling.

Wooden balcony railing with MS grill

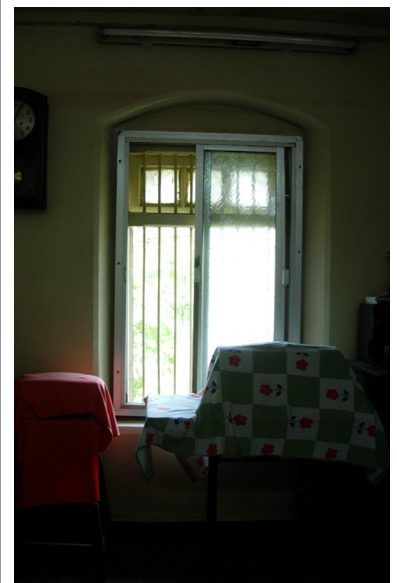
Aluminium sliding windows fixed internally without disturbing the existing wooden windows

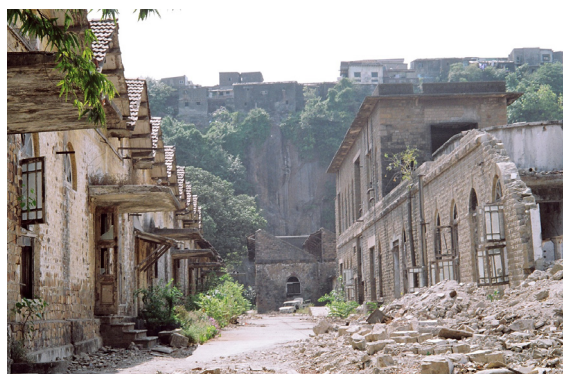
Partial area of the Mills which was destroyed in the fire

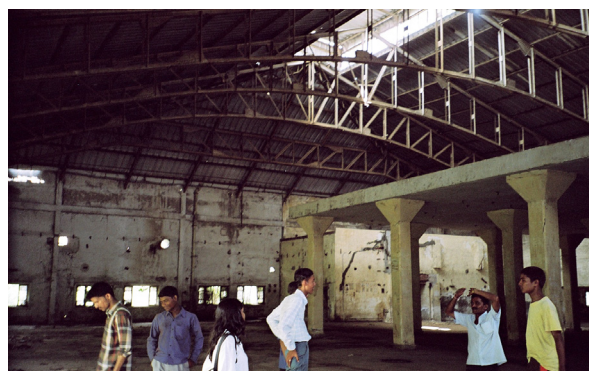
9.6	Roofing	The roof is broken at many places which causes leakage during the monsoon.
9.7	Articulation & Finishes	Poor. There is considerable weathering and environmental discoloration in the external surface.

Roofing in structural steel covering large spans

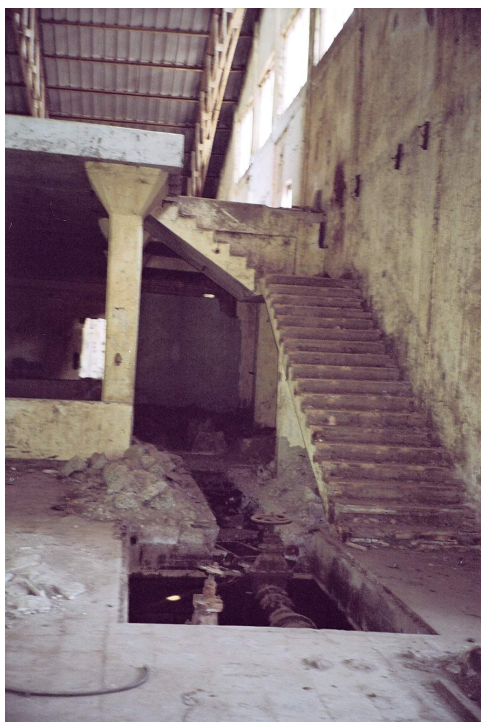
9.3	Floors	The floors have been damaged. There are cracks and crevices in the flooring which are home to pest.
9.4	Stairs	Poor, plaster is flaking
9.5	Openings	The window frames and eaves are in broken condition. Panes are also broken and the wood is in decaying state. In some places the stones used in the arches for the openings are in bad state.

The RCC staircase connecting to a mezzanine level

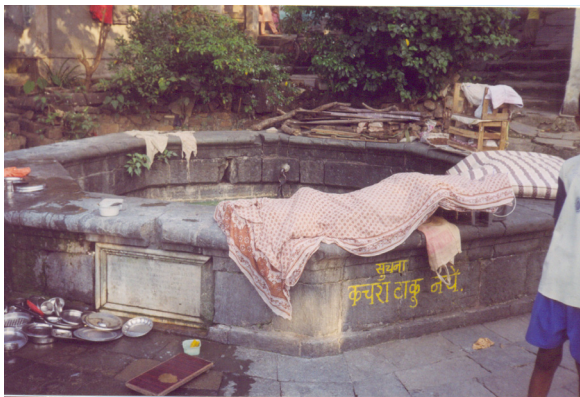
9.0	Condition	
9.1	Plinth	Fair.
9.2	Walls	Partly dislodged upper walls. Vegetation growth.
9.3	Floors	N.A.
9.4	Stairs	N.A.
9.5	Openings	N.A.
9.6	Roofing	N.A.

<p>The well constructed in basalt stone</p>

10.2	Structure	Fairly strong
10.3	Articulation & Finishes	Memorial plaque with a faded inscription
11.0	DP Remarks / Perceived Threats	
	If it remains in unused condition, it may be closed in future. Being part of old and self sustaining water system it should be revived as a stand-by water source in summer season.

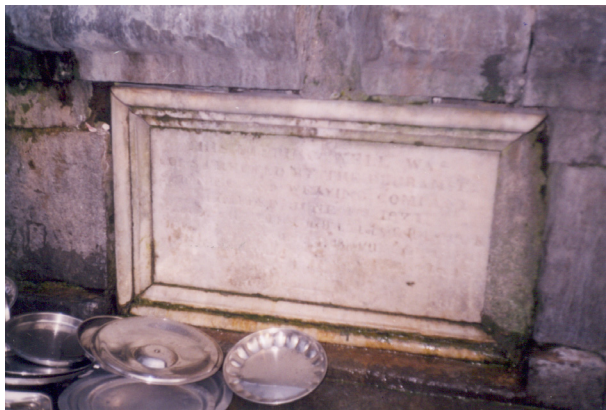
<p>A marble plaque with dedication</p>
  <p>The peripheral area of the well is paved in basalt stone</p>

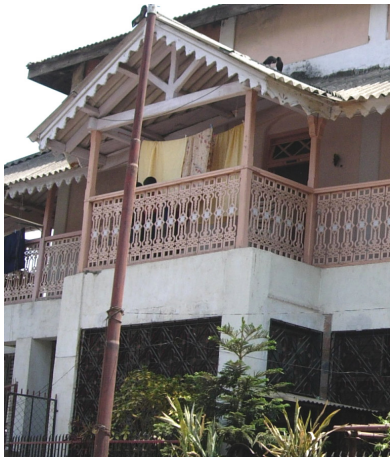
9.9	Out buildings	N.A.
9.10	Over all condition	Fair
10.0	Transformation	
10.1	Form	Extensions / modifications have changed the form to some extent
10.2	Structure	Addition of columns to support the balcony and the floor above.

The porch verandah is a feature of this house. Now it is supported by columns / MS stanchions	Arched windows and ventilators.

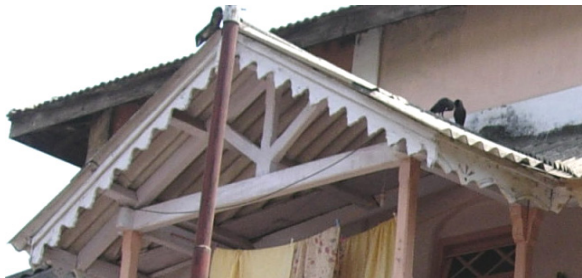
9.3	Floors	Old tile floor deteriorating
9.4	Stairs	Fair
9.5	Openings	Fair
9.6	Roofing	Fair partly damaged
9.7	Articulation & Finishes	Deteriorating
9.8	Services	Fair

Sloping roofs in timber with AC sheet roofing	Decorative wooden fascia

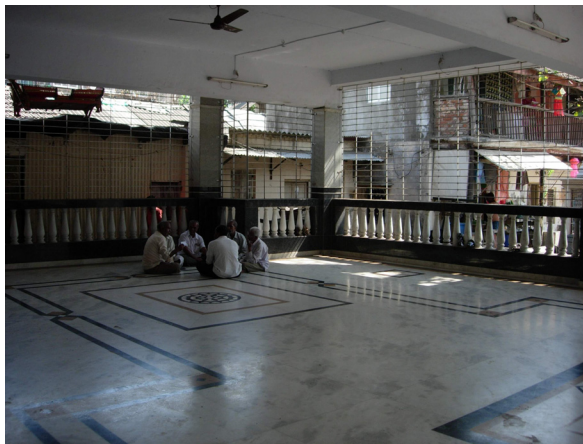
The renovated sabha mandap

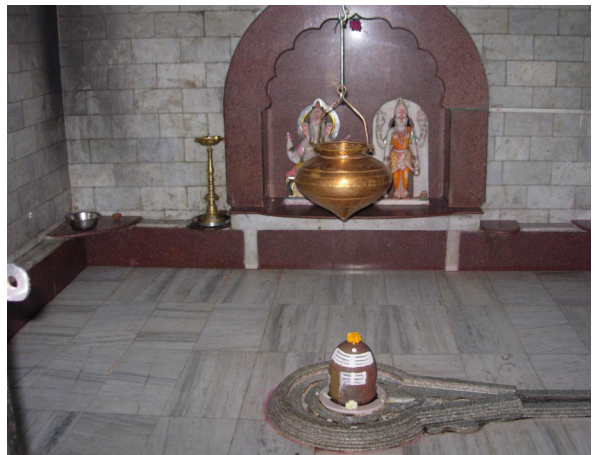
The renovated garbha griha

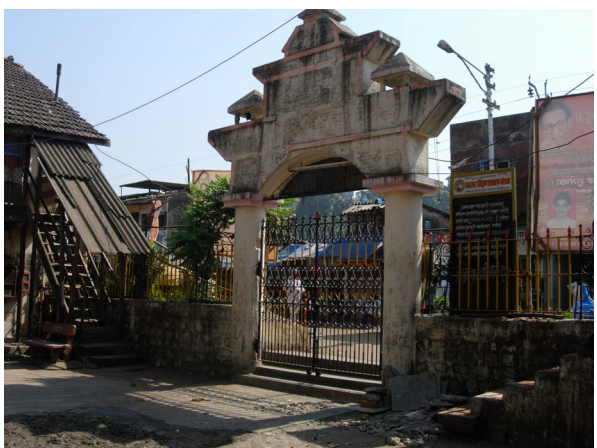
9.7	Articulation & Finishes	Fair
9.8	Services	Fair
9.9	Out buildings	Fair
9.10	Over all condition	Fair
10.0		Transformation
10.1	Form	None
10.2	Structure	Nagarkhana entrance in the compound wall has gone

The reconstructed gate

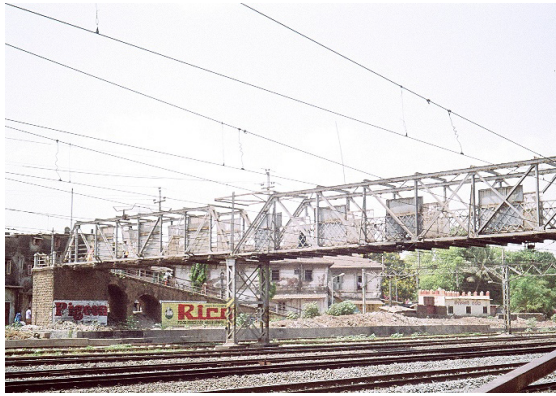
8.6	Fire precaution	N.A.
8.7	Other (HVAC/BMS/ Security Systems)	N.A.
9.0	Condition	
9.1	Plinth	Poor
9.2	Walls	Poor
9.3	Floors	Poor
9.4	Stairs	Poor
9.5	Openings	Poor

9.6	Roofing	Poor
9.7	Articulation & Finishes	Poor
9.8	Services	Poor
9.9	Out buildings	Poor
9.10	Over all condition	Poor
10.0	Transformation	
10.1	Form	None
10.2	Structure	Weathering and damage

The bridge as seen from Kurla (W)

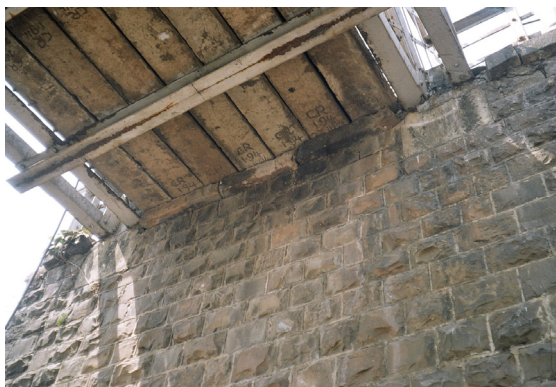
10.3	Articulation & Finishes	Weathering and damage, vegetation growth
11.0	DP Remarks / Perceived Threats	
		Destruction due to neglect, demolition, Modernisation

Coursed masonry wall supporting the floor

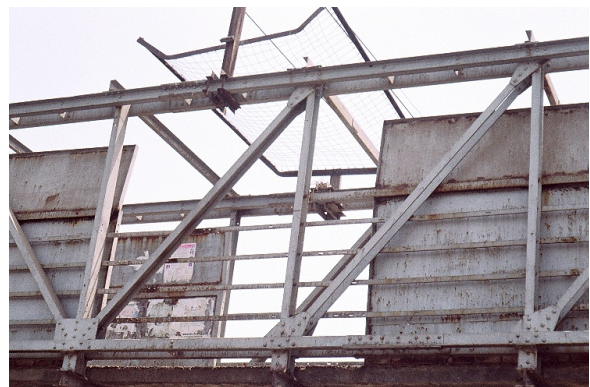
MS members forming the support system

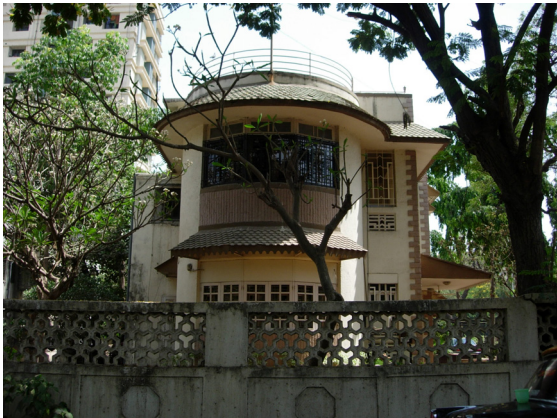
compound wall had collapsed.
10.3	Articulation & Finishes	Decorative elements such as stone cladding on walls, sloping chajjas with wooden finish have been added to front and side elevations.
11.0		DP Remarks / Perceived Threats
		Insensitive modernisation, possible demolition in the process of urbanisation
12.0		Additional Notes / References / Documents Available

The old compound wall with grill	Additions in terms of façade treatment

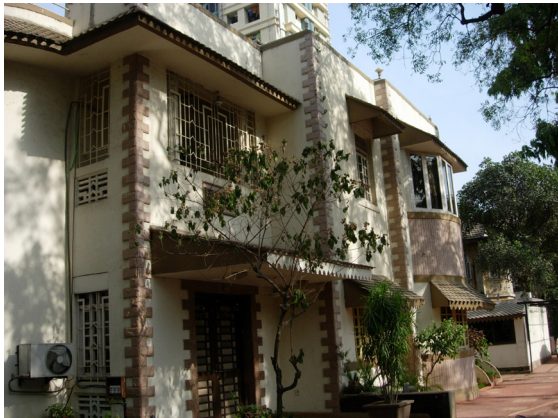
9.9	Out buildings	Moderate
9.10	Over all condition	Fair
10.0		Transformation
10.1	Form	A lot of decorative elements have been added to the old structure and it has been altered with modern elevation treatment.

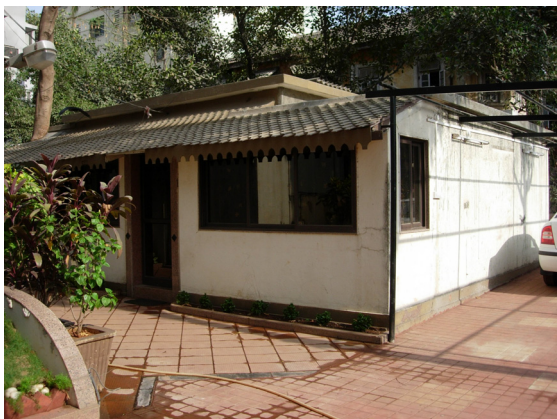
Transformation of an out house to a commercial office	Landscaped open spaces

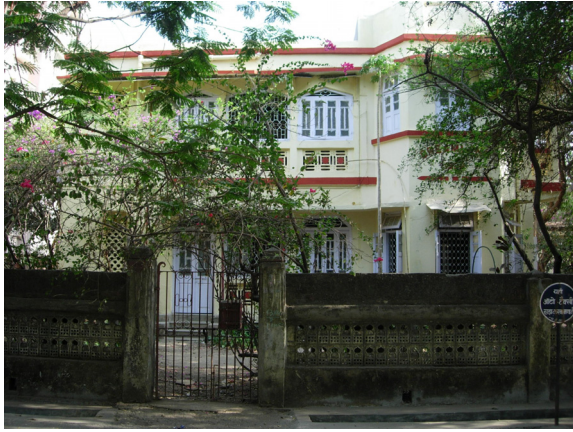
Entrance View of the House	View of balconies

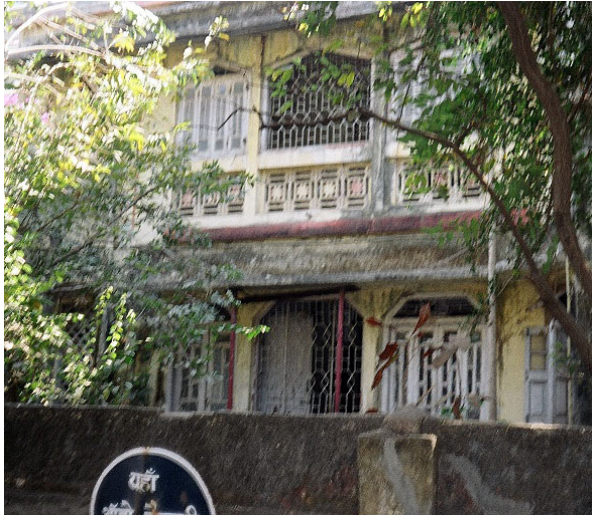
Secondary decorative gate	Side view of the house

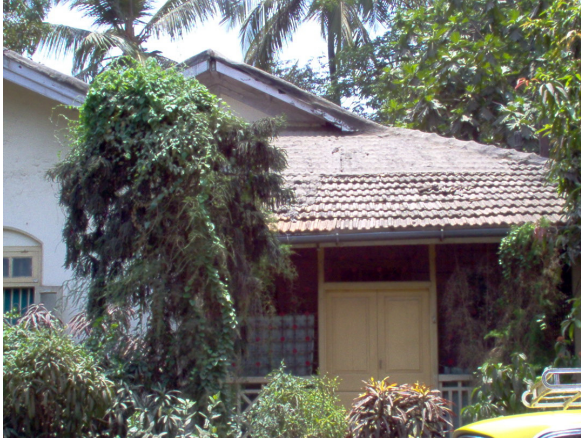
9.5	Openings	Poor
9.6	Roofing	Poor, leakages visible, Mangalore tiles damaged at a few places.
9.7	Articulation & Finishes	Deteriorating
9.8	Services	Poor

Sloping tiled roof with Mangalore tiles		Verandah with wooden railing

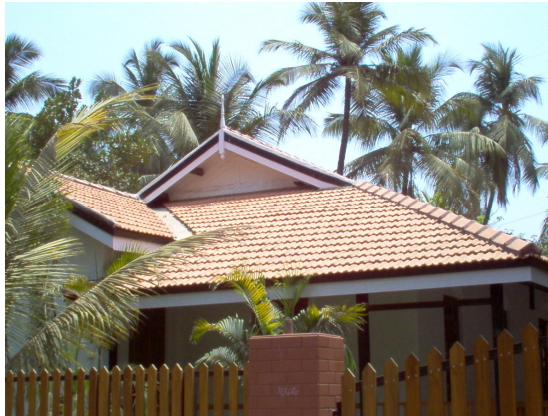
The restored roof of the house	Verandah with wooden railing

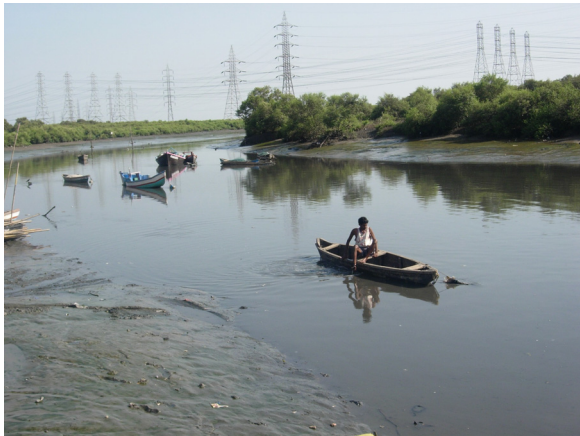
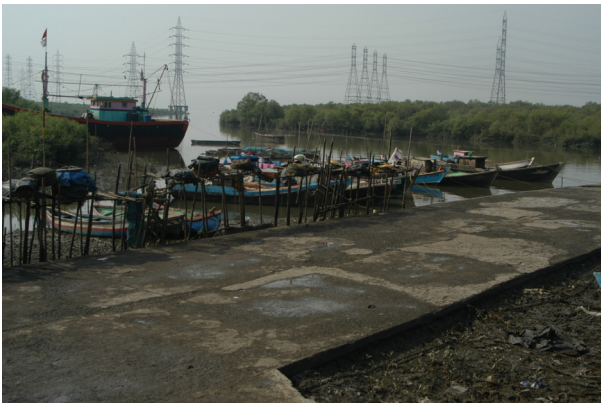
<p>Creek and mudflats</p>	<p>Jetty with the creek entry in the background</p>

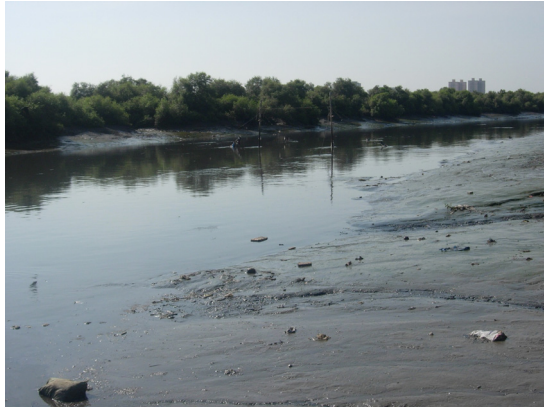
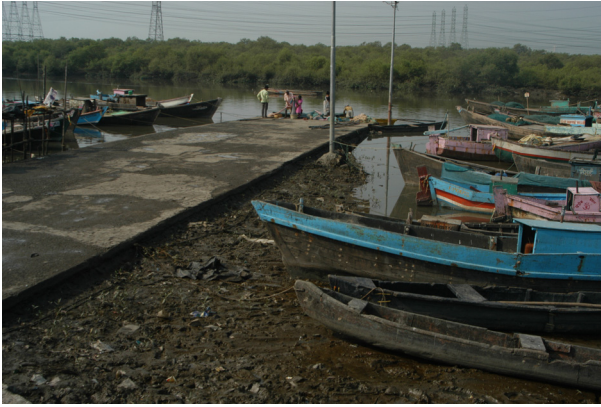
<p>Creek, mudflats, pollution</p>	<p>Jetty with boats</p>

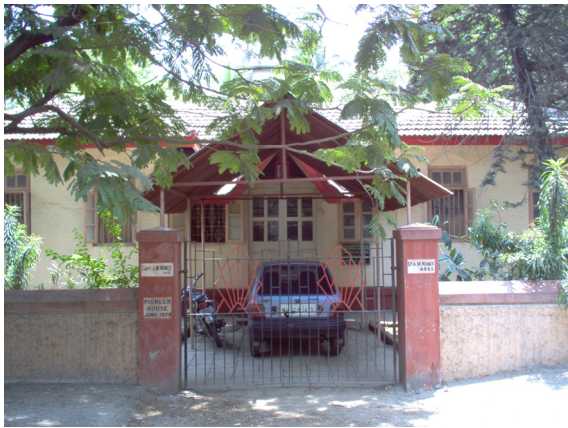
10.3	Articulation & Finishes	Deteriorating
11.0		DP Remarks / Perceived Threats
		Insensitive modernisation, possible demolition in the process of urbanisation

Corrugated G.I. sheet added as a porch	Sloping timber and mangalore tiled roof

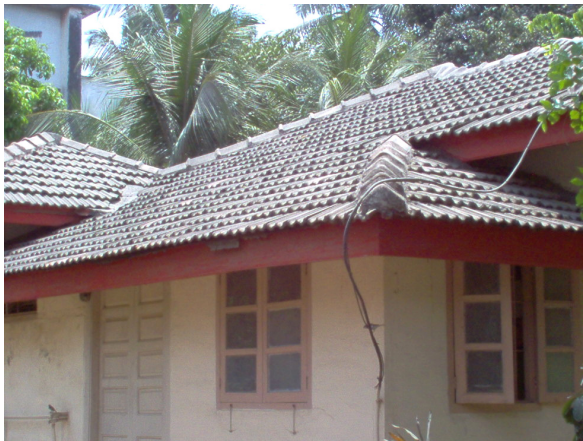
9.2	Walls	Fair
9.3	Floors	Poor, intermittent settlement
9.4	Stairs	Fair
9.5	Openings	Fair
9.6	Roofing	Poor, Leakages visible, needs maintenance
9.7	Articulation & Finishes	Poor, Deteriorating

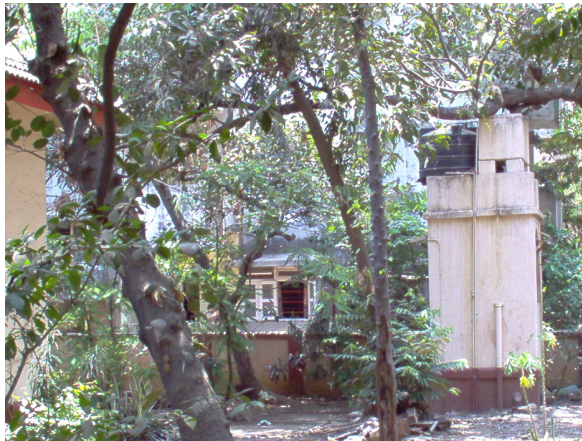
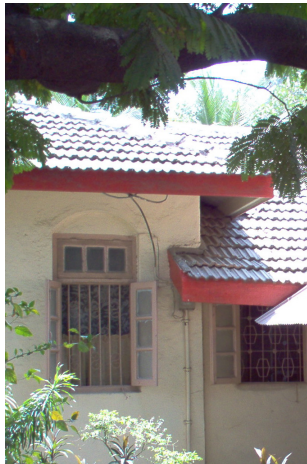
Toilet block outside the villa	Arched window openings with wooden shutters

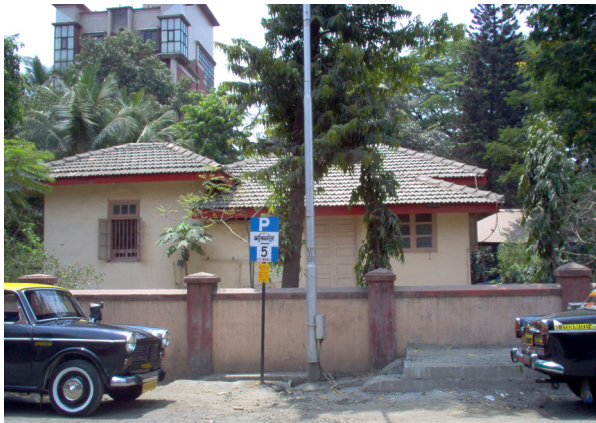
8.5	Drainage / Plumbing and Sanitation	MCGM
8.6	Fire precaution	No
8.7	Other (HVAC/BMS/ Security Systems)	Piped gas service
9.0		Condition
9.1	Plinth	Plinth level is higher on the east side than on north side due to ground level difference.

Part of the compound wall buried under the road	Rear view of the house

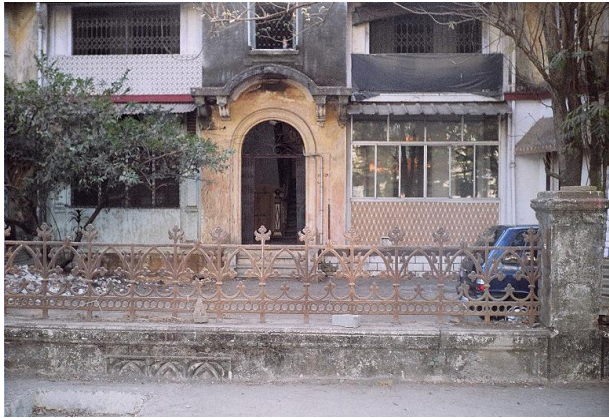
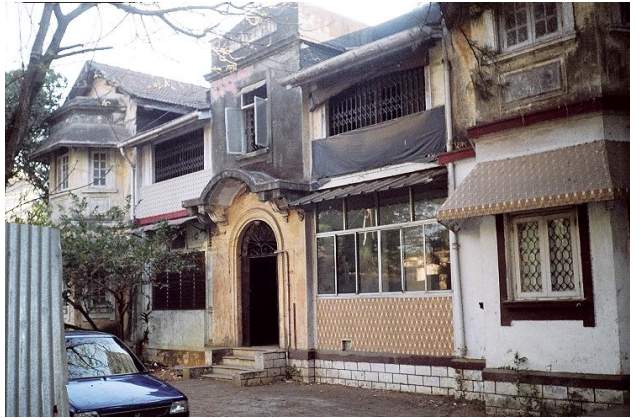
8.7	Other (HVAC/BMS/ Security Systems)	Piped gas service
9.0		Condition
9.1	Plinth	Plinth level has reduced approximately 0.50m as the existing road level is higher than finishing plinth level

<p>Front elevation with various materials use in openings and compound wall</p>	<p>Front view</p>

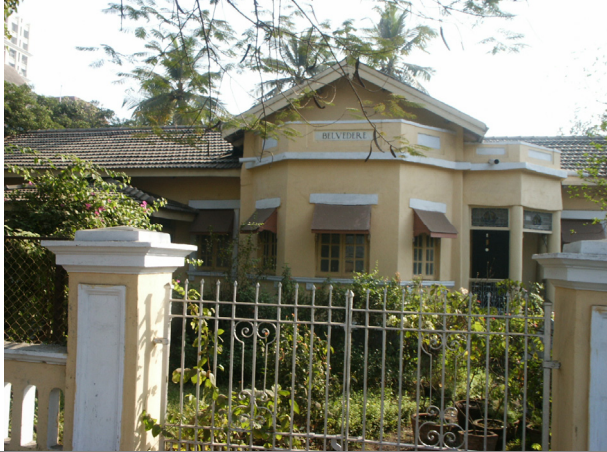
<p>Front view</p>

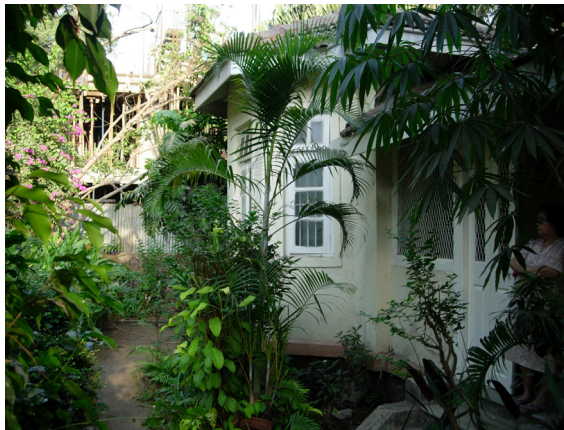
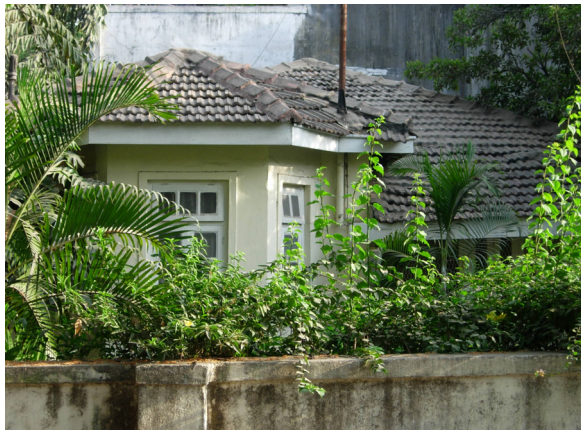
9.3	Floors	Poor, settlements
9.4	Stairs	Fair
9.5	Openings	Fair
9.6	Roofing	Poor condition of sloping roof
9.7	Articulation & Finishes	Fair
9.8	Services	Poor

Side view of the cottage	The bay window

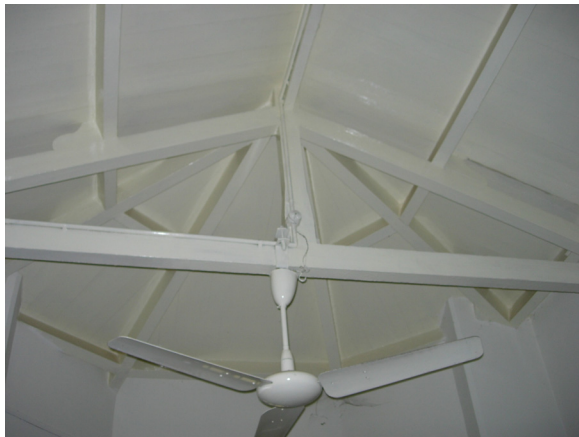
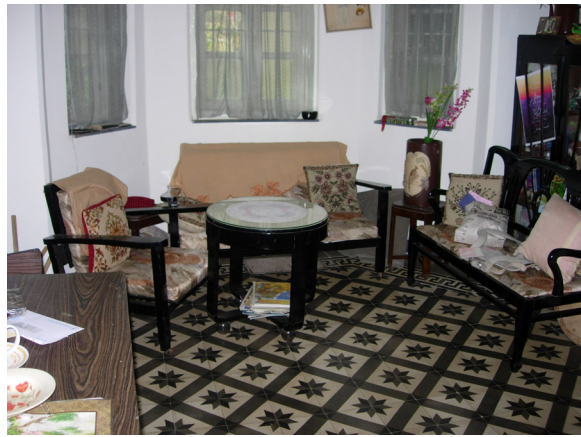
Wooden trusses and planking	Ceramic mosaic tiles for flooring

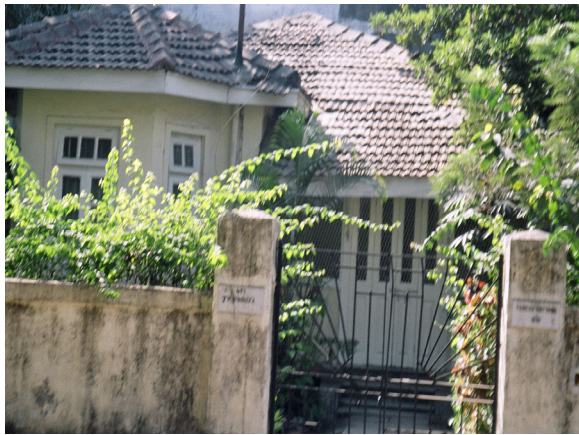
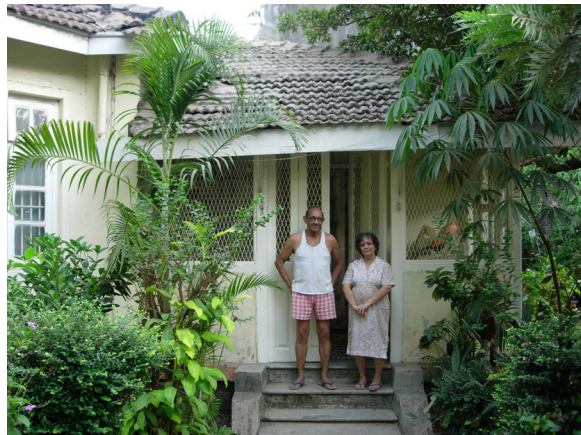
8.6	Fire precaution	No
8.7	Other (HVAC/BMS/ Security Systems)	Piped gas service
9.0		Condition
9.1	Plinth	Fair, some settlement.
9.2	Walls	Poor. The compound wall is deteriorating and walls have cracks at a few places.

The main entrance gate from road no 13	Entrance overlooking the small garden

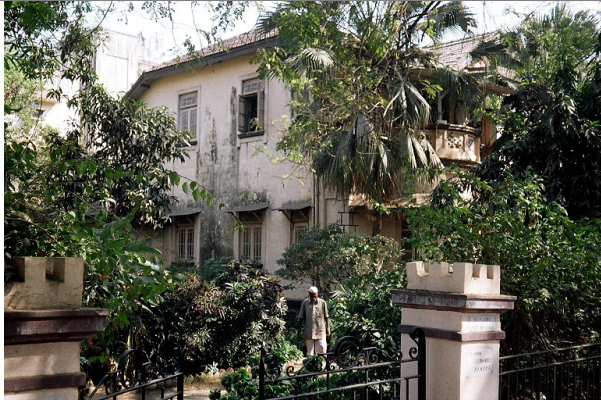
View of the house from the road

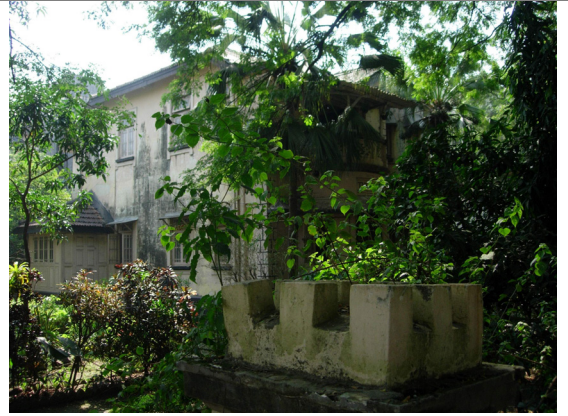
Rear view of the house

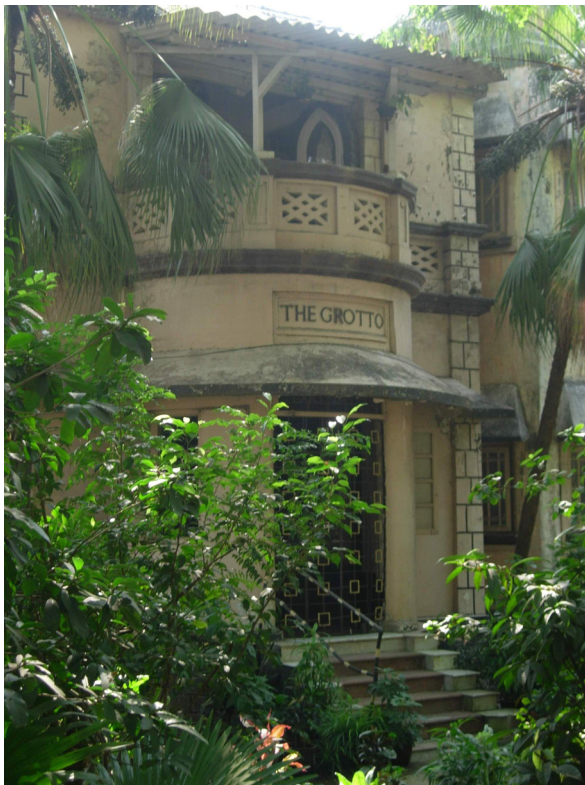
Circular balcony over the entrance area

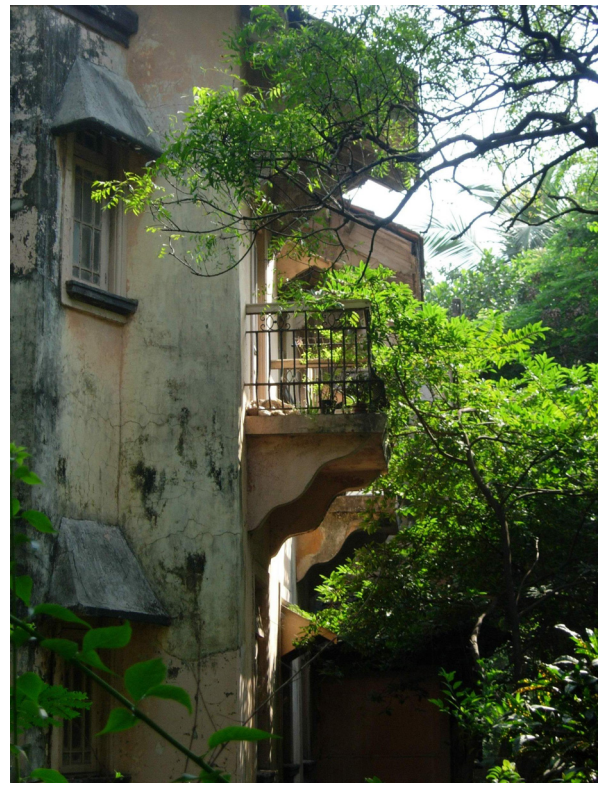
Concrete brackets supporting balconies

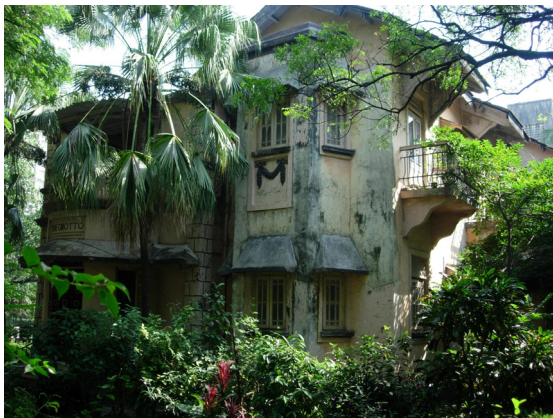
9.7	Articulation & Finishes	Fair
9.8	Services	Fair
9.9	Out buildings	Fair
9.10	Over all condition	Fair
10.0		Transformation
10.1	Form	Additional floor / extension. Weather shades and chajjas have been added

Addition of chajjas

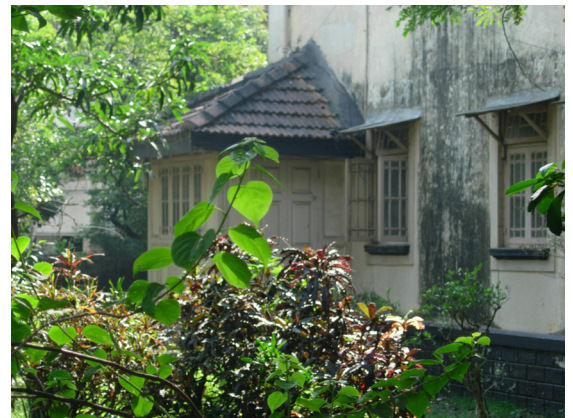
Bay window

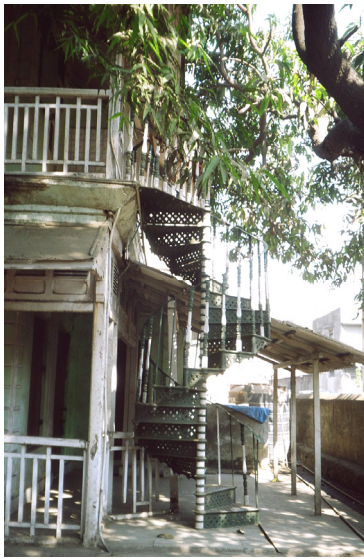
8.7	Other (HVAC/BMS/ Security Systems)	No
9.0		Condition
9.1	Plinth	Fair
9.2	Walls	Fair
9.3	Floors	Poor, Wooden floors sagging.
9.4	Stairs	Poor, Wooden stairs worn out.

Wooden balconies & Spiral staircase	Wooden staircase and verandah

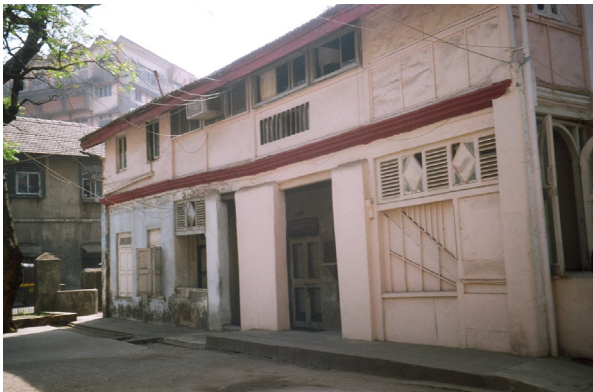
Surrounding road level has increased	Arched windows with wooden shutters. Louvered ventilators

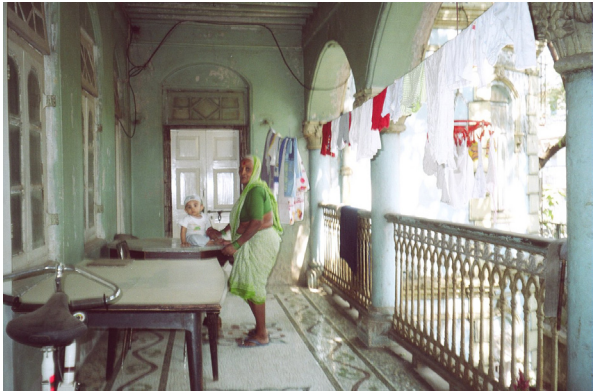
8.7	Other (HVAC/BMS/ Security Systems)	No
9.0		Condition
9.1	Plinth	Good
9.2	Walls	Good
9.3	Floors	Floor sagging at places
9.4	Stairs	Wooden staircase worn out

<p>Mosaic flooring, old wooden furniture</p>	<p>Mosaic flooring for verandah</p>

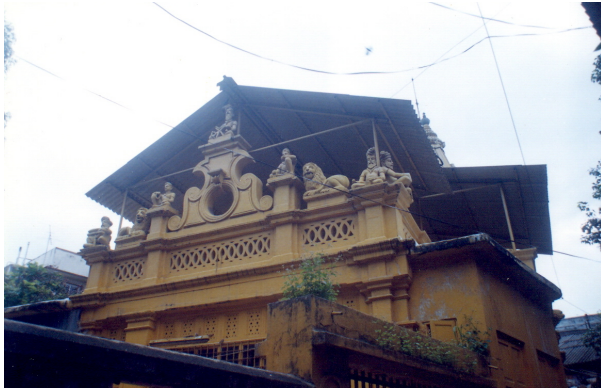
9.8	Services	Fair
9.9	Out buildings	Bad
9.10	Over all condition	Fair
10.0		Transformation
10.1	Form	Modern modifications, Additions/extensions changing the temple form. The temple open space covered with aluminium sheets on tubular GI pipes.

Addition of AC sheet sloping roof

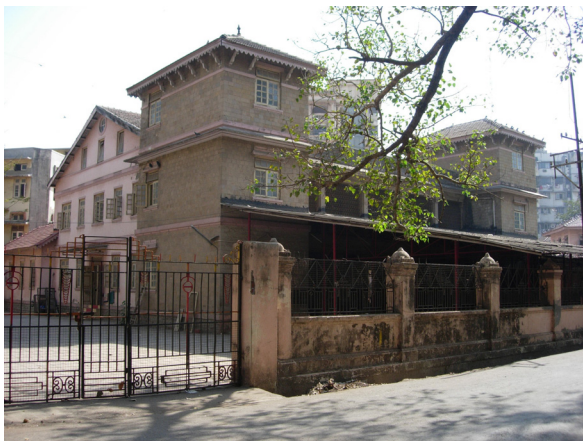
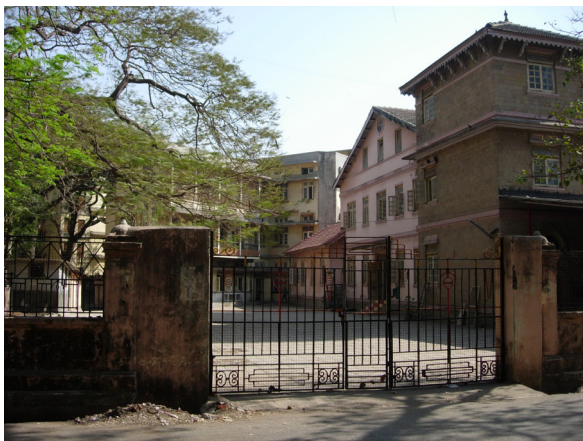
<p>Northwest view of the main structure with addition of new structures over the years.</p>

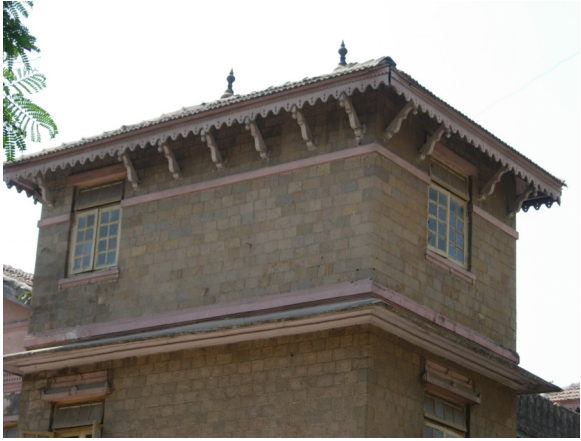
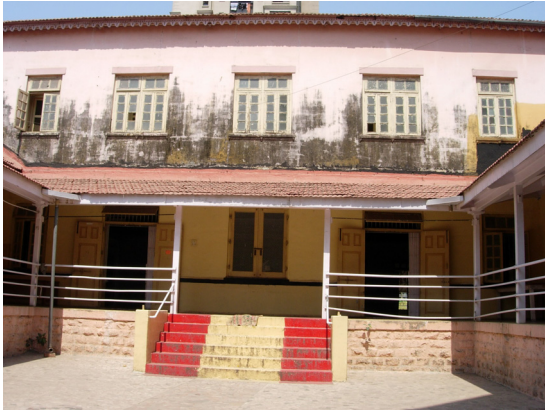
9.5	Openings	Fair
9.6	Roofing	Poor, Leakages
9.7	Articulation & Finishes	Sloping roof, false ceiling and decorations have started deteriorating due to water seepage.

9.8	Services	Fair
9.9	Out buildings	Fair
9.10	Over all condition	Fair
10.0		Transformation
10.1	Form	Addition of many new buildings behind the main structure in later years and covering of front open space with corrugated sheets on tubular steel truss.

View of the roof of the main structure	Addition of the new structure to the old

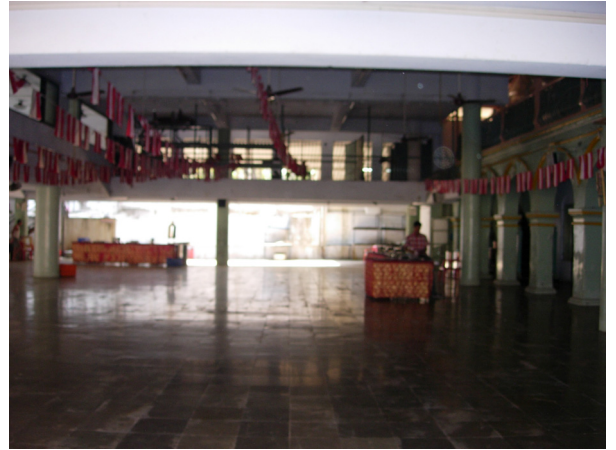
9.8	Services	Fair
9.9	Out buildings	Fair
9.10	Over all condition	Good
10.0		Transformation
10.1	Form	Addition of multipurpose hall by covering the front open space of community hall. The front open space of the temple is covered by G.I. sheet shed to house the temple office and a drinking water fountain.

View of the new addition to old community hall

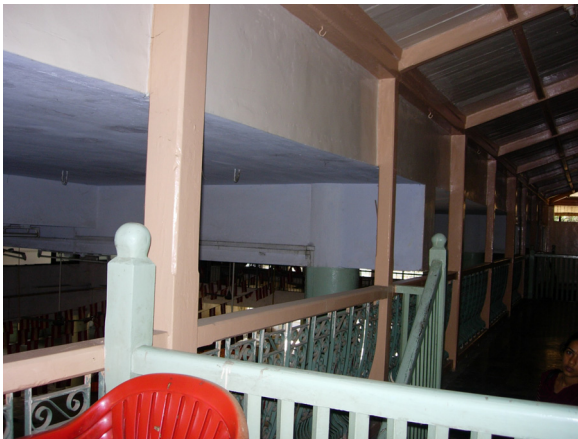
View of the new addition to old community hall

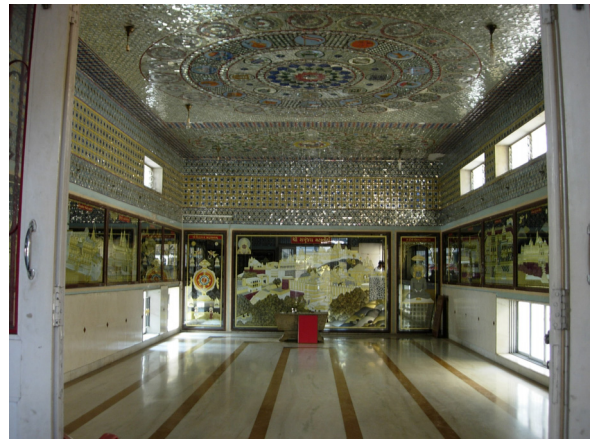
View of new addition to main temple

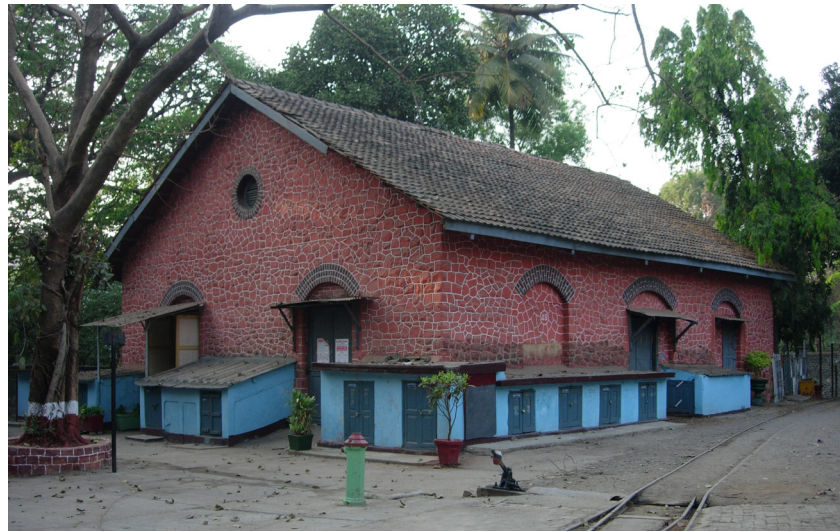
collapsed and is being redone Store: The floor finish has developed some cracks
9.4	Stairs	Poor: The steel staircase needs maintenance.
9.5	Openings	Fair. Some of the windows are permanently closed. Regular painting works are carried out.

The store building with the trolley tracks in the foreground

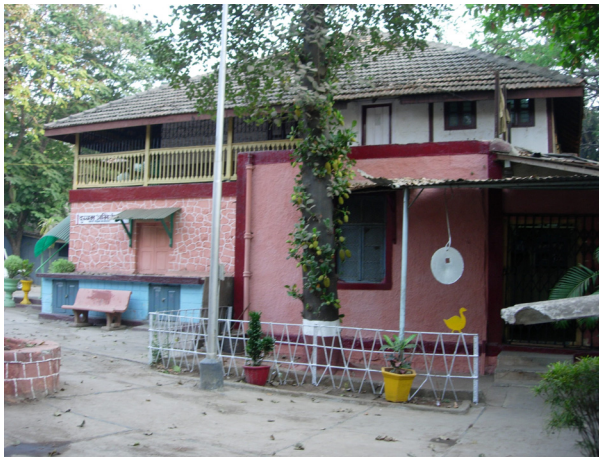
Additional structure is constructed next to the building

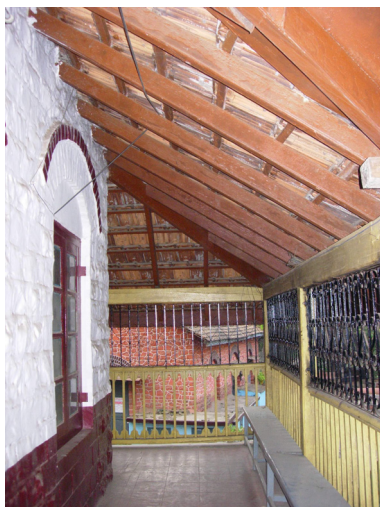
Verandah on the first floor of Office building

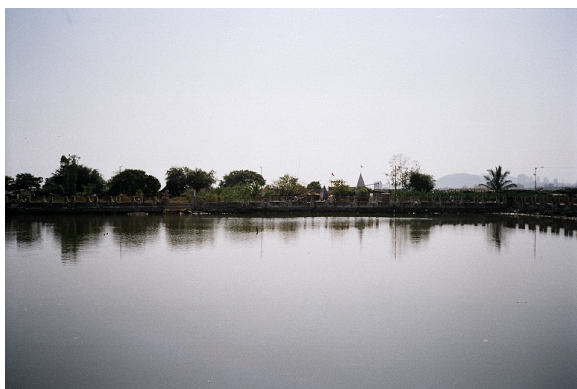
The Kund is full of water in monsoon

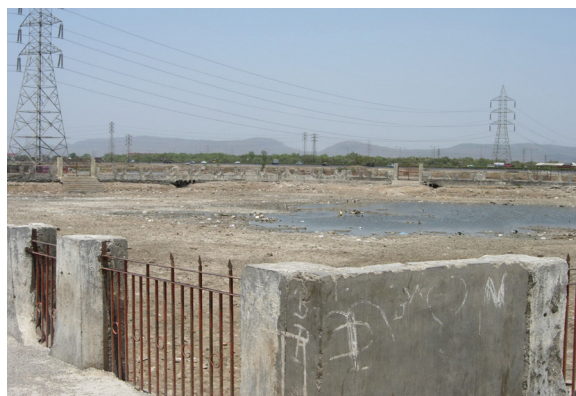
9.8	Services	A number of drains open in the tank contaminating the water. During the dry season the tank has only waste water
9.9	Out buildings	N.A.
9.10	Over all condition	Poor and neglected. The tank remains dry for over 6 months and is polluted. The compound wall is weak

The same kund post-monsoon having waste water

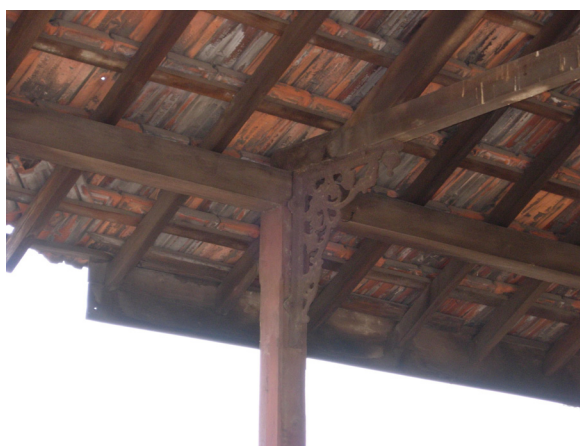
Iron brackets supporting the roof

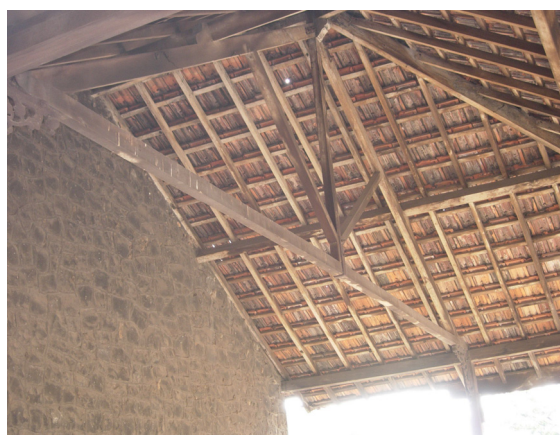
The roofing system in wood

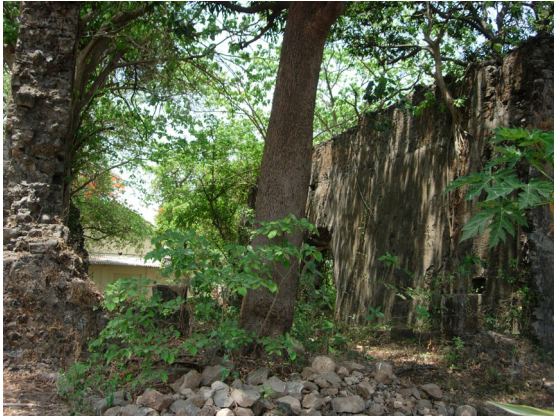
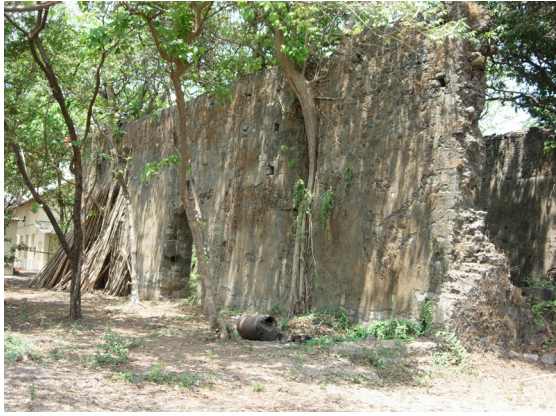
9.1	Plinth	Poor, Settlements
9.2	Walls	Poor, crumbling, vegetation growth
9.3	Floors	Poor, crumbling
9.4	Stairs	N.A.
9.5	Openings	Poor, Lots of cracks developed.

The ruins with vegetation around them	The walls have arched punctures

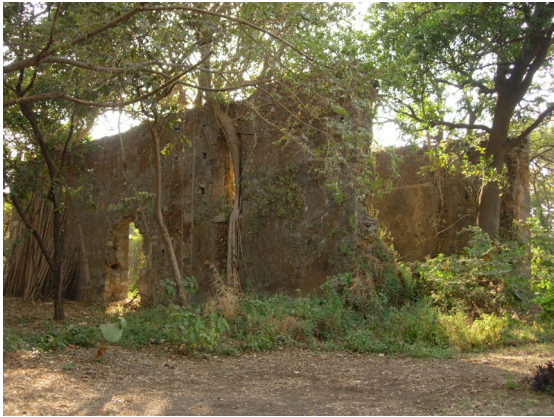
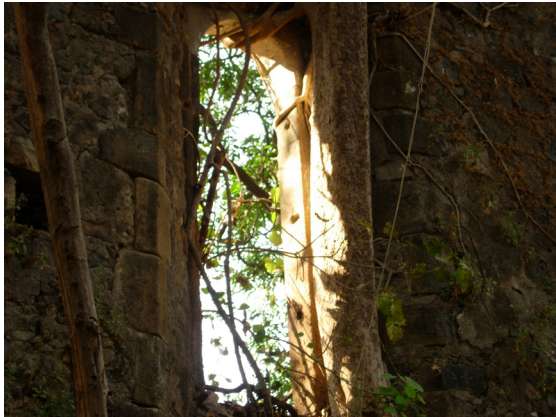
9.6	Roofing	Destroyed
9.7	Articulation & Finishes	Very poor.
9.8	Services	Very poor.
9.9	Out buildings	N.A.
9.10	Over all condition	Very poor
10.0		Transformation

Ruin walls	Coursed stone masonry for the opening

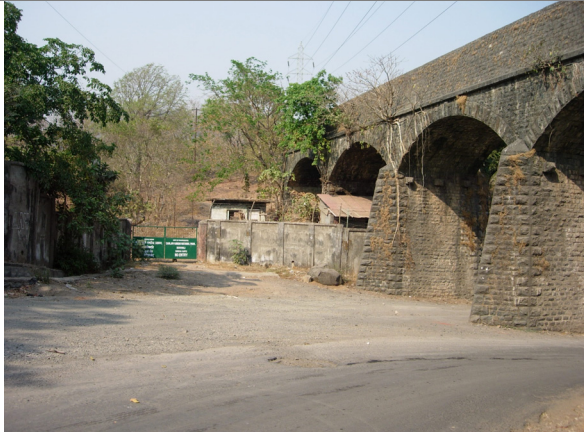
9.0		Condition
9.1	Plinth	The existing road level has increased due to development works affecting plinth level
9.2	Walls	At some places vegetative growth can be seen. Various illegal structures are coming along the aqueduct taking its support Wall is broken at some places because of encroachment. The walls seem to have weathered considerably. Dark patches on the stone walls can be noticed and discolouration has affected some portions.

<p>Aqueduct from road junction</p>	<p>Aqueduct and surrounding encroachments</p>

12.0		Additional Notes / References / Documents Available
		Lost its glory & original look due to neglect, illegal encroachments in surrounding & misuse by local people. Requires immediate restoration and conservation since this is an excellent example of traditional technology.

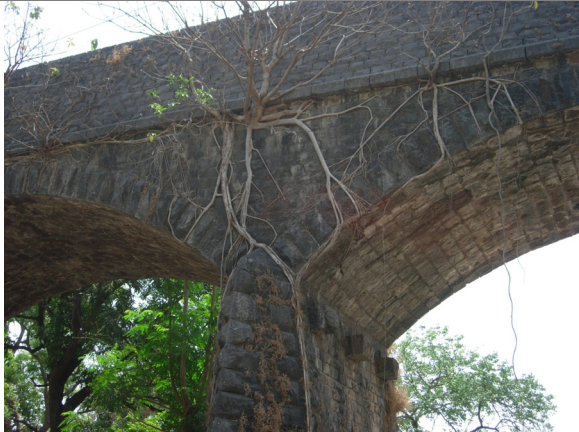
10.2	Structure	The original duct seems to be filled in / covered.
10.3	Articulation & Finishes	Overgrowth of vegetation on the masonry
11.0		DP Remarks / Perceived Threats
		Neglect, weathering, destruction, encroachments

<p>Vegetation growth on arches and pillars</p>	<p>Masonry pillar</p>

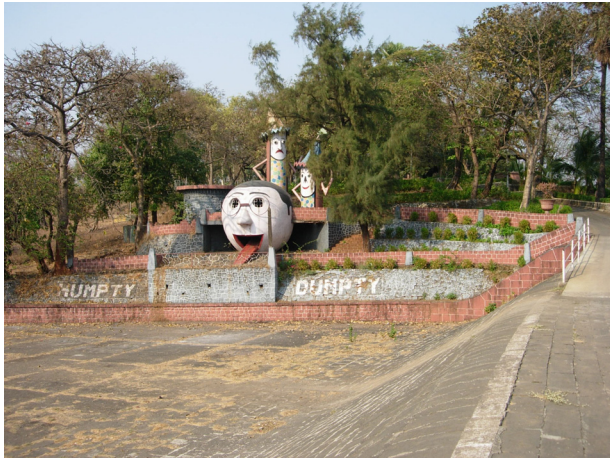
7.11	Curtilege / unbuilt space / out buildings / landscape	The front area of the dam is also paved in basalt stone. Residential quarters, offices, water level markers, weir, are built in the surroundings also have heritage value. However various play equipments lie in abandoned and dilapidated condition in the surroundings.

'Humpty Dumpty' – Children's play area, which is now closed for security reasons	Downstream side of the waste weir

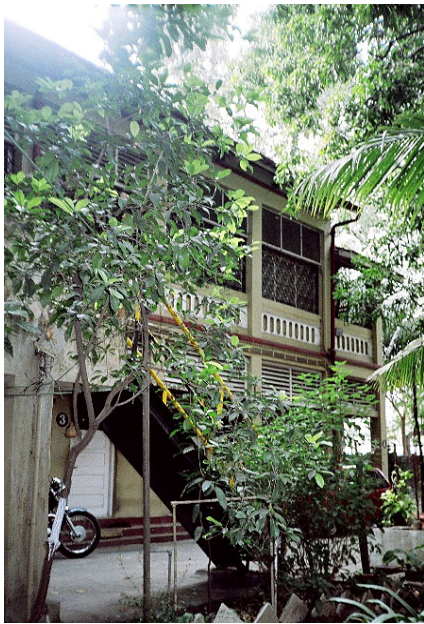
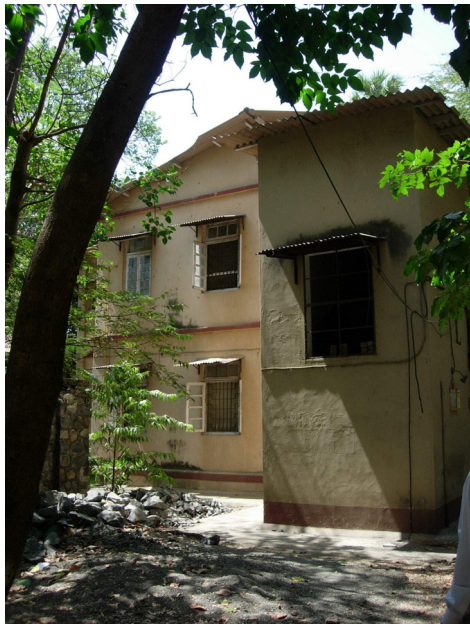
9.4	Stairs	Fair
9.5	Openings	Fair, projections need repairs
9.6	Roofing	Fair
9.7	Articulation & Finishes	Fair but maintenance required
9.8	Services	Fair
9.9	Out buildings	N.A.

Balconies and landscape	View

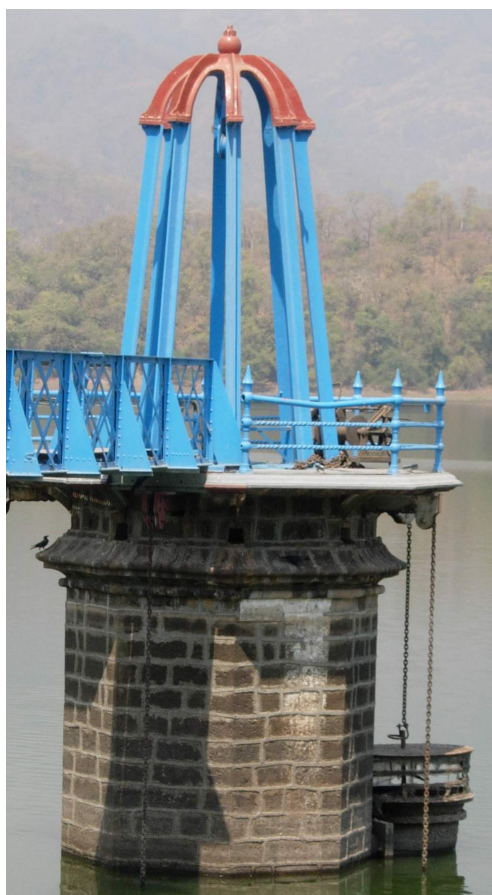
The outlet Tower with Plugs and Strainers
