TABLE OF CONTENTS		
		LIST 'A'		
Sr. No	Ward	Listed Properties	Page No	Grade
1	L	225-L-Reporter House	001-004	III
2	L	301-L- Swadeshi Mills	005-009	IIB
3	L	415-L-Well	010-012	III
4	L	614-L-Tank at Kale Road	012-016	IIB
5	L	706-L-Holy Cross Church	017-020	IIB
6	L	709-L-Paul-Periera House	021-023	III
7	L	727-L-Sarveshwar Mahadev Temple	024-027	III
8	L	878-L-Pereira House	028-030	III
9	L	909-L-Foot Over-Bridge	031-033	III
10	M	202-M-Diwan Bawdi	034-036	III
11	M	208-M-Dieal	037-040	III
12	M	209-M-Joseph Haven	041-044	III
13	M	212-M-Dream Land	045-047	III
14	M	215-M-Pam Cote	048-050	III
15	M	217-M-Mathildes	051-055	III
16	M	224-M-Ganesh Talao	056-058	IIB
17	M	604-M-Allbless Leper Home	059-062	III
18	M	607-M-Mahul Jetty	063-065	III
19	M	609-M-Ashish Tank	066-068	IIB
20	M	642-M-Pioneer House	069-071	III
21	M	643-M-Marian Mansion	072-074	III
22	M	644-M-Belvedere House	075-077	III
23	M	863-M-Teresa Cottage	078-080	III
24	M	864-M-The Grotto	081-083	III

225-L		REPORTER HOUSE

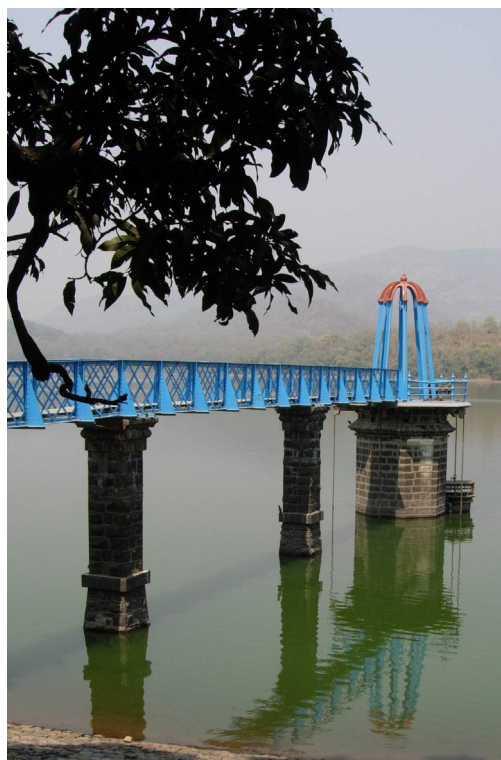
8.7	Other (HVAC/BMS/ Security Systems)	N.A
9.0		Condition
9.1	Plinth	Good
9.2	Walls	Good
9.3	Floors	N.A
9.4	Stairs	N.A
9.5	Openings	N.A
9.6	Roofing	N.A
9.7	Articulation & Finishes	The super structure in steel and the bridge seems to have been painted recently and seem very bright compared to the rest of the structure.

A bridge connecting the Outlet Tower

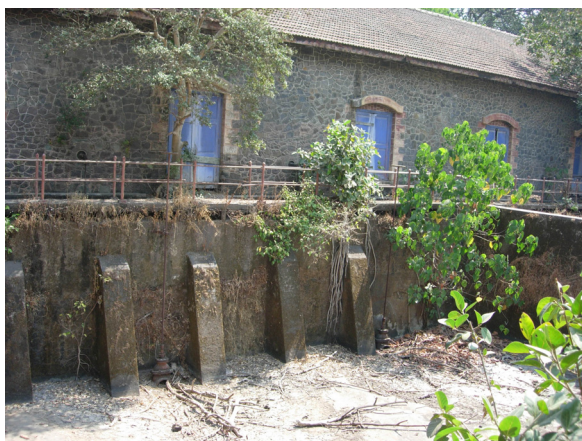
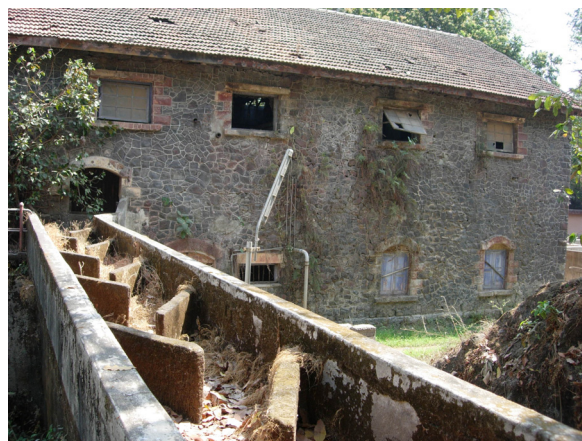
8.4	Water Supply	MCGM
8.5	Drainage / Plumbing and Sanitation	MCGM
8.6	Fire precaution	N.A.
8.7	Other (HVAC/BMS/ Security Systems)	N.A
9.0		Condition
9.1	Plinth	Poor, The plinth shows signs of settlement and leakage.

9.2	Walls	Poor, The pointing at places is absent. Plenty of vegetation growth is seen.
9.3	Floors	Poor, The floors are showing signs of settlement and also there are leakage problems.

Masonry structure with other infrastructure features

Masonry structure and other features

9.8	Services	Poor, None of them are in working condition. There is no electric supply at present
9.9	Out buildings	Abandoned and neglected.
9.10	Over all condition	As the building is abandoned the structure is almost dying a slow death. Extensive restoration measures will have to be taken to bring it to its

earlier functional / usable condition
10.0		Transformation
10.1	Form	Neglect and deterioration
10.2	Structure	Neglect and deterioration
10.3	Articulation & Finishes	Neglect and deterioration
11.0		DP Remarks / Perceived Threats
		As the building is abandoned, it may soon be demolished or will decay.
12.0		Additional Notes / References / Documents Available
		The old structures associated with historical technology narrate history and could be conserved with adaptive reuse.

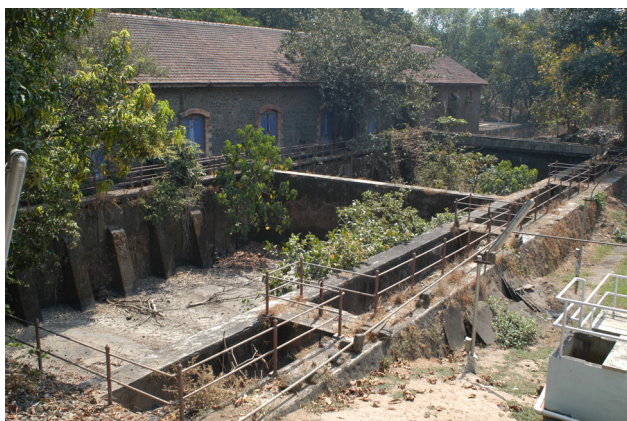
Tanks, channels & weed invasion

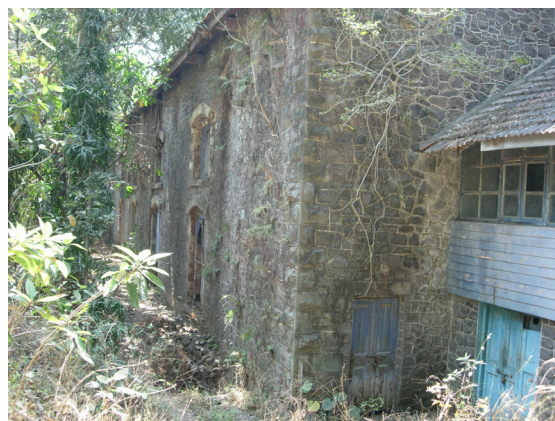
Neglected masonry and weeds

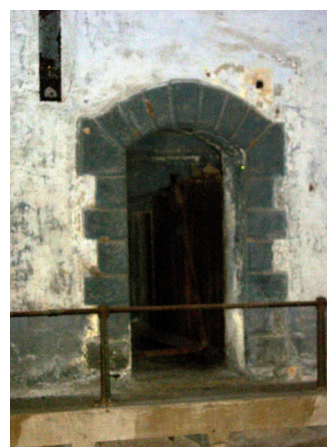
9.6	Roofing	Poor, The roof has gaping holes and it leaks heavily in the monsoon
9.7	Articulation & Finishes	Poor, The plaster over the brick segmental arches is missing. The handrails are missing at many places.

Masonry arch opening

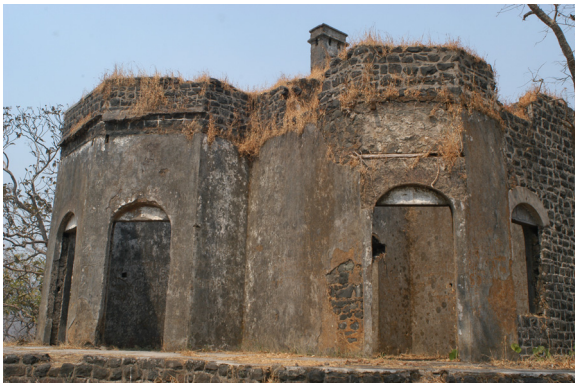
9.2	Walls	Poor, The walls are showing slight bulge. There are plant outgrowths at places
9.3	Floors	Poor, The floors are cracked and show settlement at places.

9.4	Stairs	N.A.
9.5	Openings	The frames and shutters are missing.
9.6	Roofing	The roof is totally collapsed and absent
9.7	Articulation & Finishes	No
9.8	Services	No

Side view, octagonal rooms and chimney

9.9	Out buildings	Caretaker's outhouse in poor condition
9.10	Over all condition	Poor, The structure though abandoned and with plenty of 'missing' elements still can be revived through sensitive conservation.

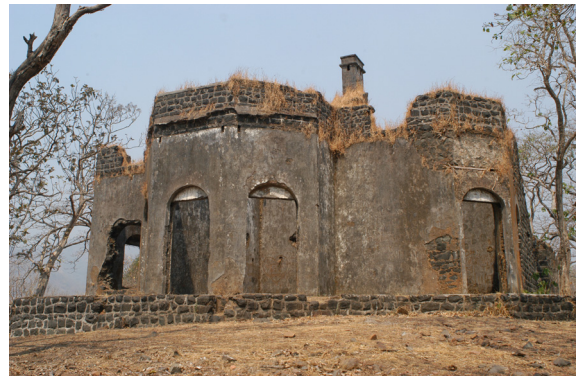
Front view

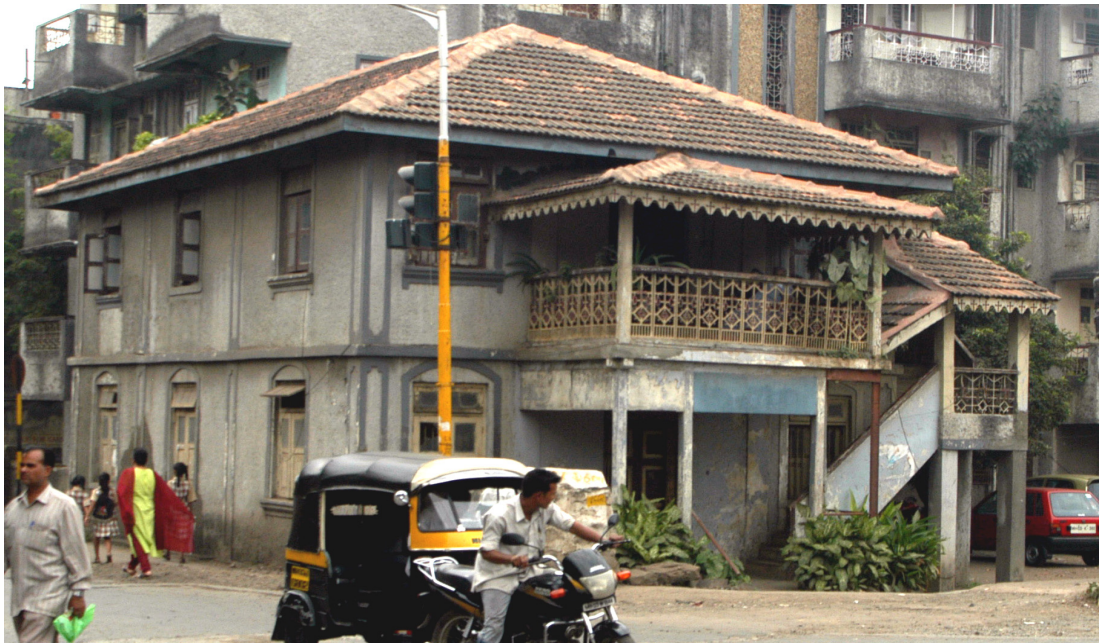
View Of the House as seen from Lal Bahadur Shastri Road

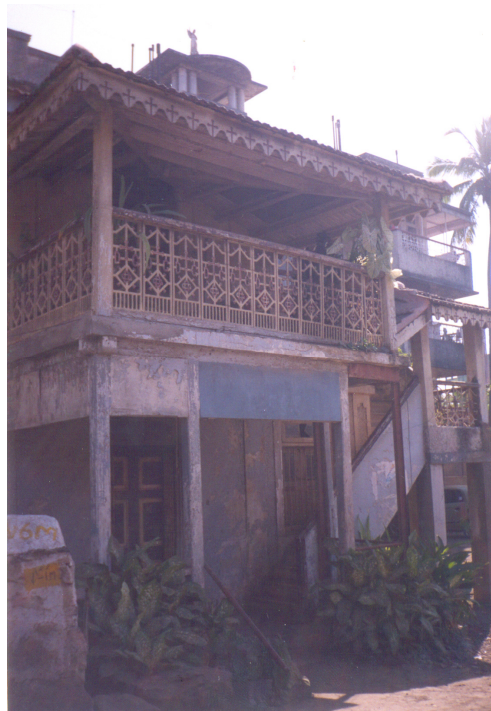
A close view of the first floor wooden balcony

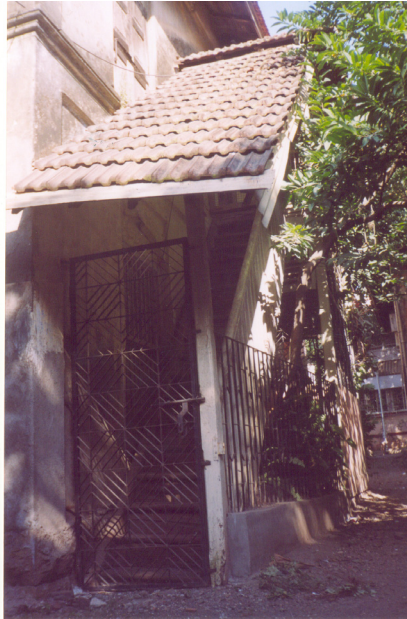
10.0		Transformation
10.1	Form	Not known
10.2	Structure	MS box grills added to door Mangalore tiles being replaced by GI sheets at some places
10.3	Articulation & Finishes	N.A.

Externals Covered staircase 1st floor

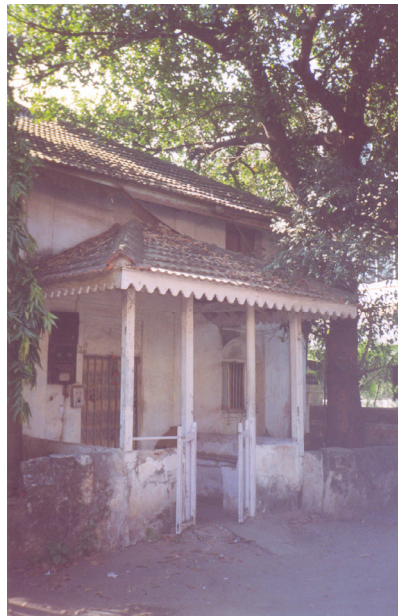
Entrance Veranda

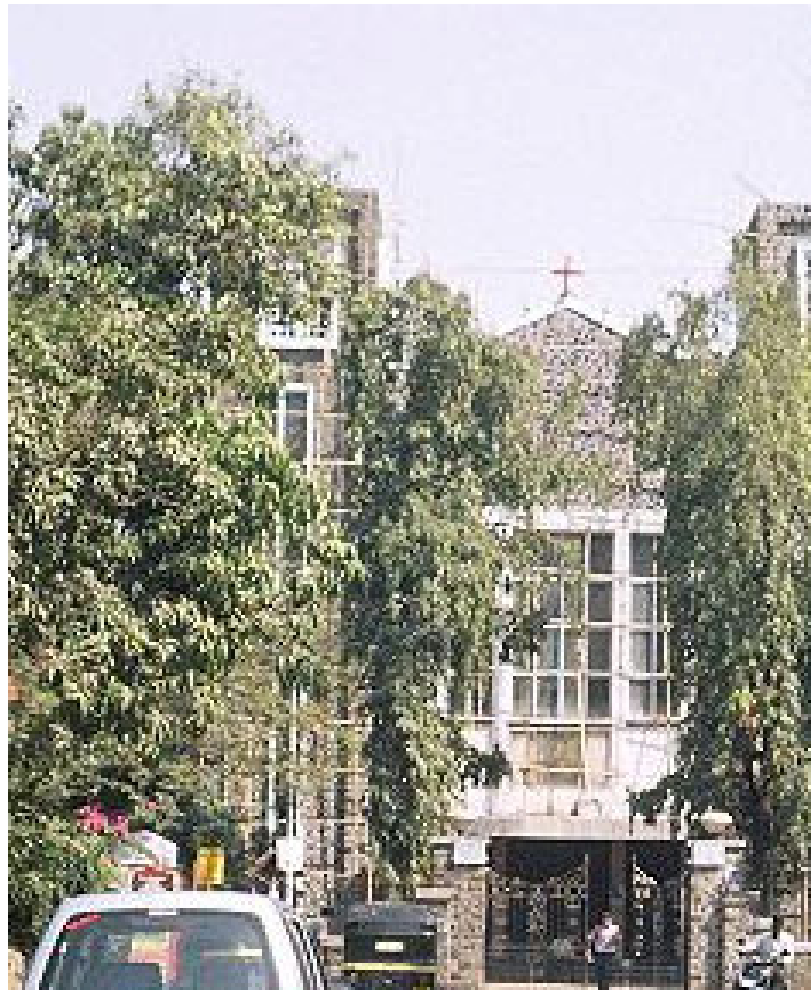
St Anthony's church as seen from the road

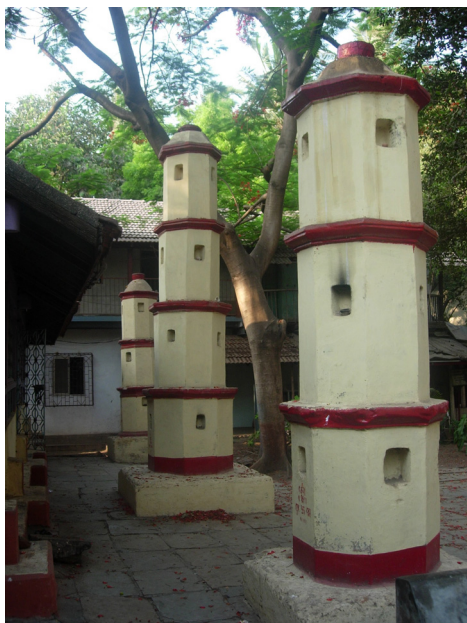
Deep malas within the campus

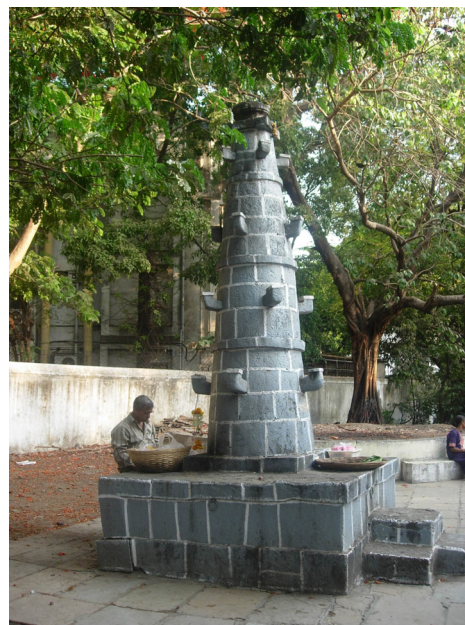
10.3	Articulation & Finishes	Some elements changed due to painting
11.0		DP Remarks / Perceived Threats Modernisation, Any insensitive redevelopment by the trust may result in a loss of its heritage / spiritual identity

Stone deepmala – now painted

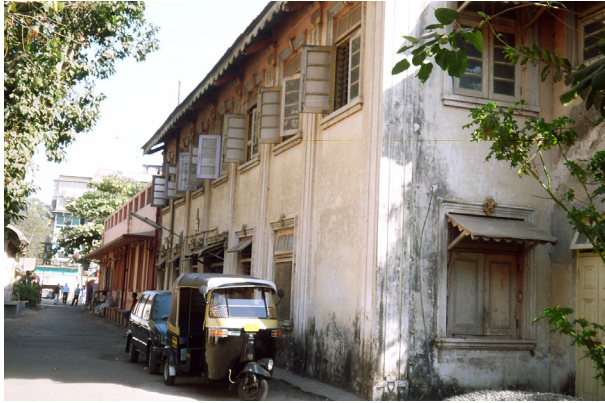
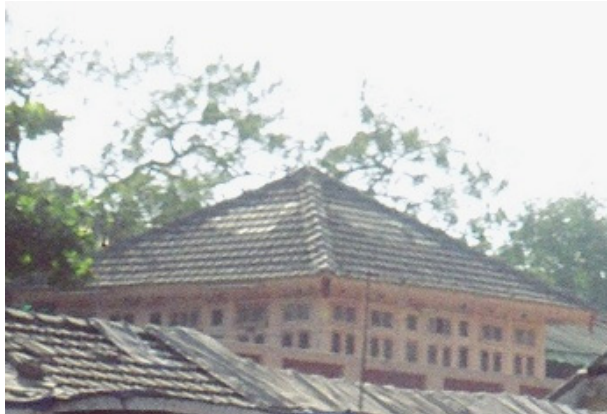
10.0		Transformation
10.1	Form	Retains original form.
10.2	Structure	Mangalore tiles being replaced by GI sheets at some places
10.3	Articulation & Finishes	Minor repairs / additions for maintenance, new finishes

Side view of the temple and the temple complex	Road side view of the Haveli temple shikar.

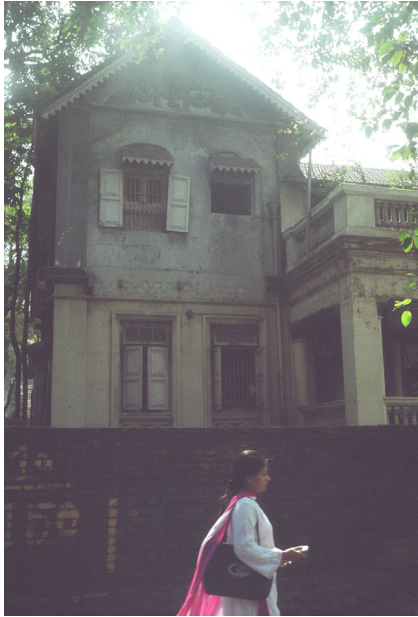
Front view

9.5	Openings	Needs maintenance and repairing work as the lining of openings has come down
9.6	Roofing	Not known
9.7	Articulation & Finishes	Not known
9.8	Services	Not known

9.9	Out buildings	Not known
9.10	Over all condition	Appears fair but needs maintenance
10.0		Transformation
10.1	Form	Not known
10.2	Structure	Not known
10.3	Articulation & Finishes	Not known

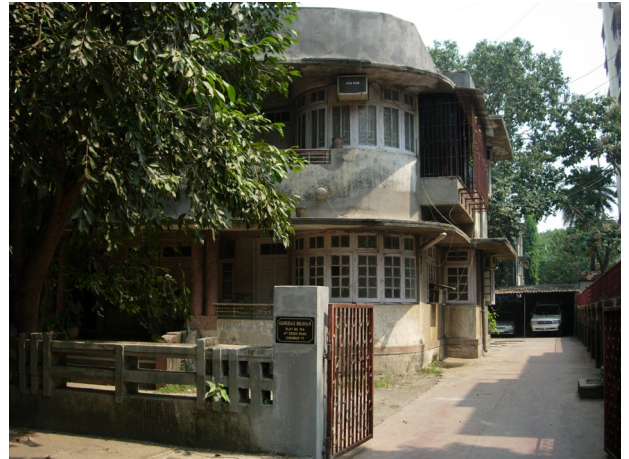
G+ 1 bungalows – transforming in form

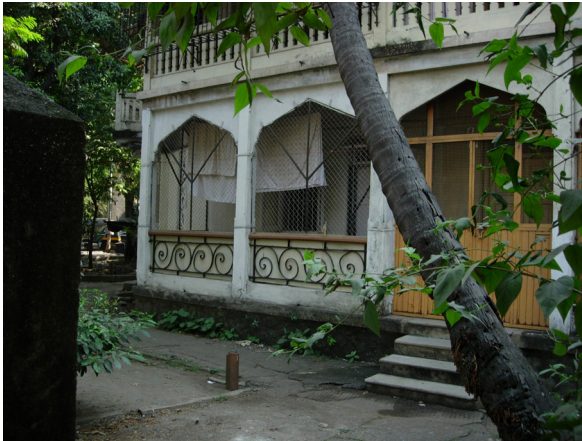
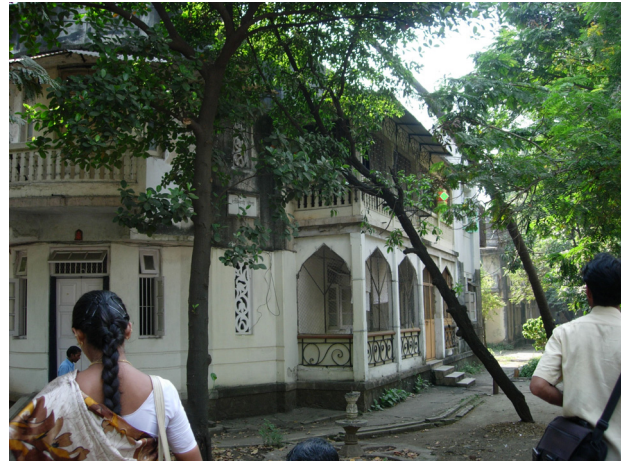
Old houses in state of disrepair

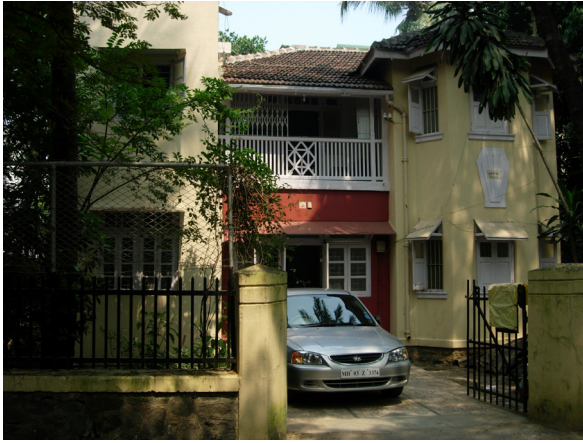
Transforming houses

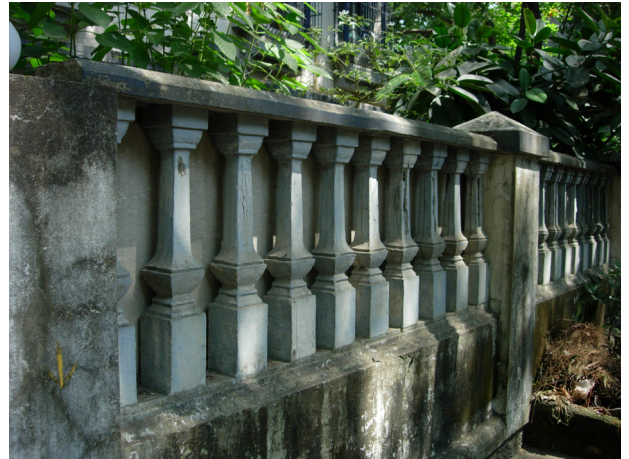
Additions to decorative compound walls

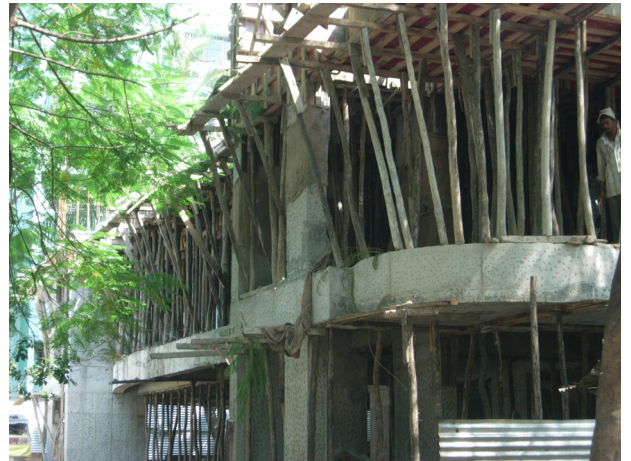
New constructions are fast replacing old bungalows
